**Campaign code:**  
L636-A.17.25

**Campaign name:**  
KOMBI Popup SafeCP and KeyLightON issues

**Model:**  
Urus S, Urus Performante

**VIN Involved:**  
From RLA26085 to RLA32360

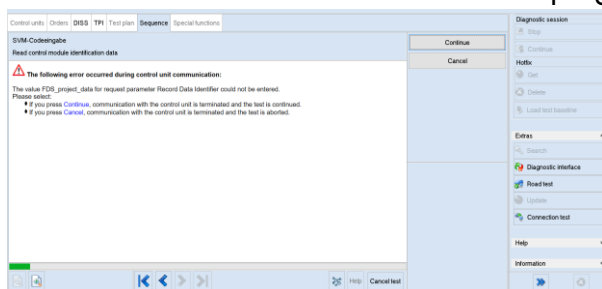
32. If the following error screen is displayed, the error does not indicate an issue, please press “Continue” and continue with the campaign.

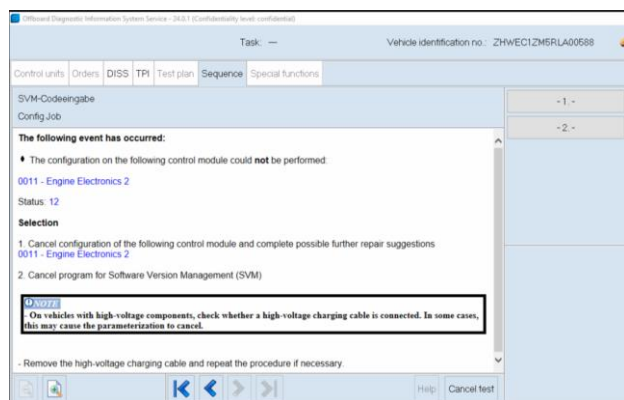
**ECU 0011 - Status 12 →** the error does not indicate an issue and can be continue with the next step of the campaign. Please, select **option 1** to go ahead.

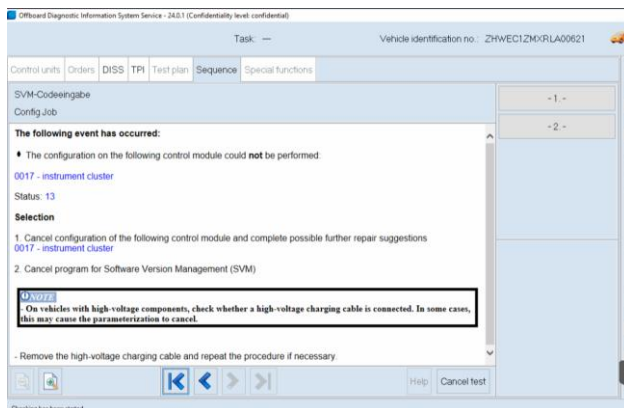
**ECU 0017 - Status 13 →** the error does not indicate an issue and can be continue with the next step of the campaign. Please, select **option 1** to go ahead

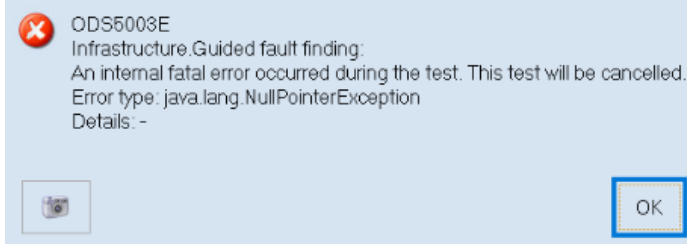
**ODS5003E →** If the following screen appears please close and repeat the SVM-Code.

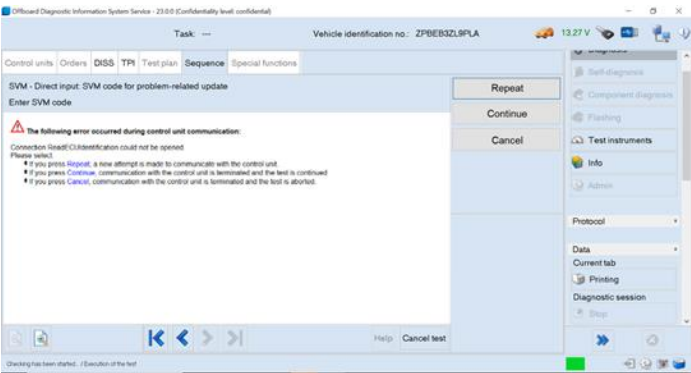
**A.** If the following error screen is displayed, abort the guided function by clicking on “Cancel Test” and contact Technical Support.

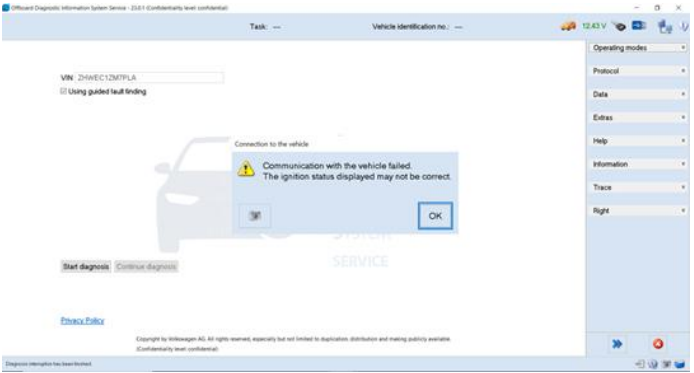
**B.** If an error is displayed that regards the hardware interface, and the "connection to vehicle" and "key state" icons appear as shown in the figure below:

- Click “Cancel”;
- Repeat installation of the interface 6154/6154A/6154B for the instructions in procedure (\*) “Checking the VAS 6154”, selecting the right-hand “Extras” menu in O.D.I.S. and clicking on the “Diagnostic interface” button.

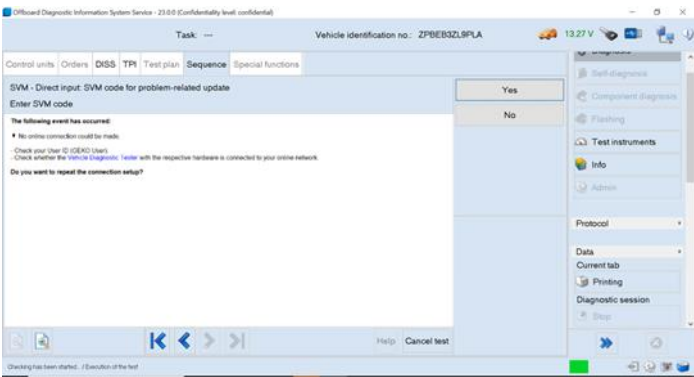
**C.** If the following connection error is displayed like in the following example screenshots:

- It is not possible to connect to the central server; check that your laptop is correctly connected to the Internet and retry by clicking on “Yes” or “Done/continue”, as appropriate.

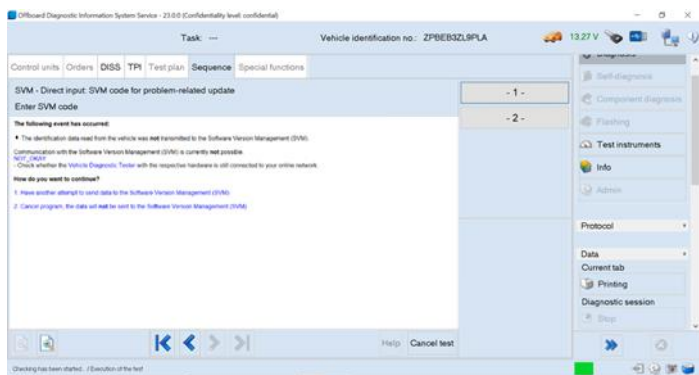
**D.** If the connection is dropped during the course of the target/actual comparison during the SVM procedure:

- It is not possible to connect to the central server; check that your laptop is correctly connected to the Internet and retry by clicking on “I”.
