Technical Service Bulletin

Topic	Service info: Leather Damage/Anomalies All Models
Market area	Bentley: worldwide (2WBE),China 796 VW Import Comp. Ltd (Vico), Beijing (6796)
Brand	Bentley
Transaction No.	2078395/1
Level	EH
Status	Released for publishing
Release date	Sep 8, 2025

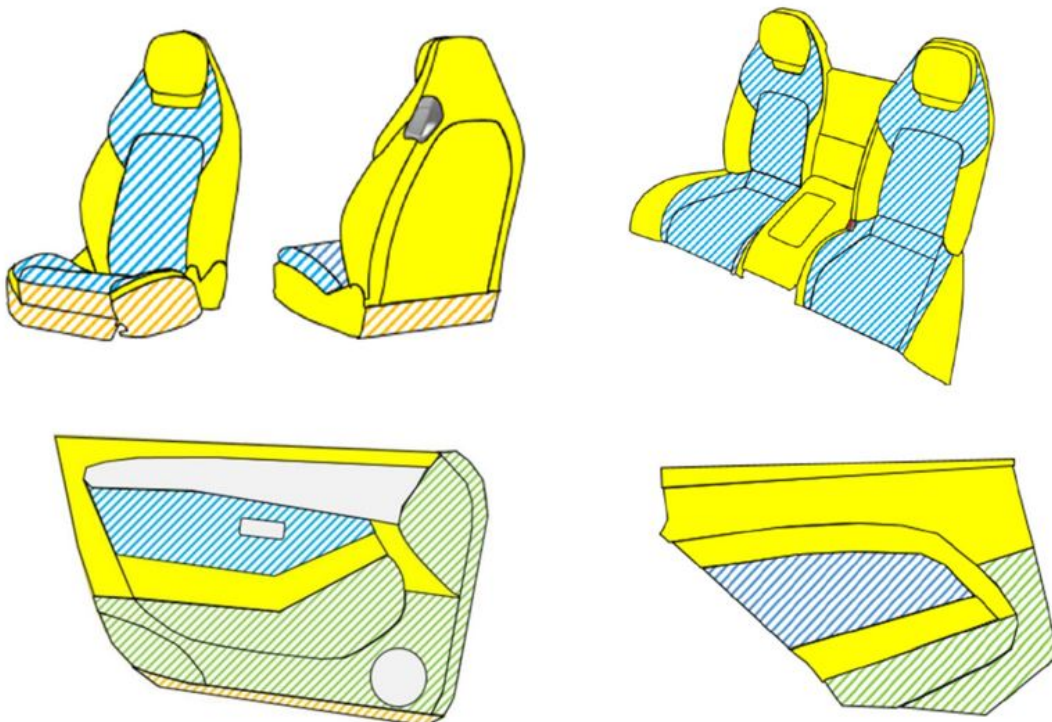
Continental GT/GTC

Zone A / (Quilted) Zone B
