**Campaign code:**  
L74X-A.22.25

**Campaign name:**  
Hood puffer washer rust

**Model:**  
Revuelto

| <b>L74X-A.</b><br><b>22.25</b> | <b>To:</b> After Sales Official Network<br><b>Subject:</b> Hood puffer washer rust<br><b>Date:</b> 15/09/2025<br><b>Pages</b> 4 | |

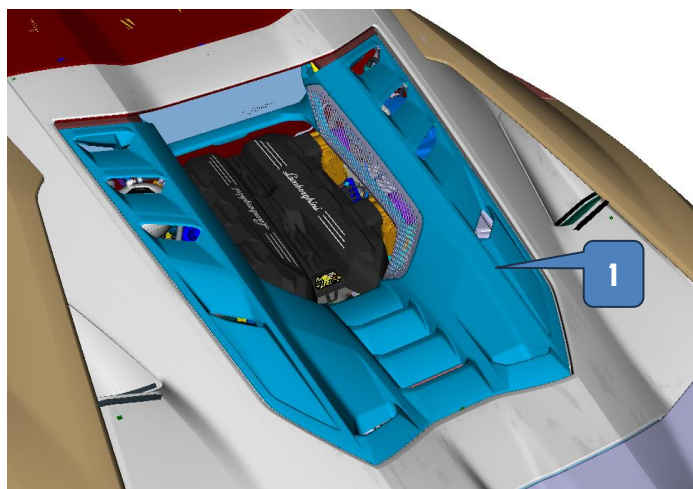
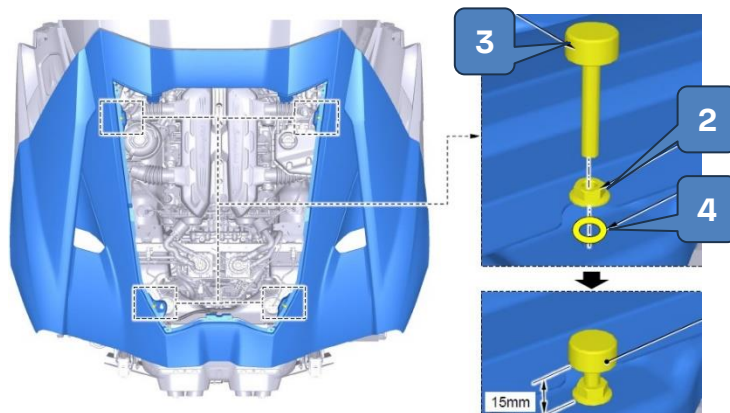
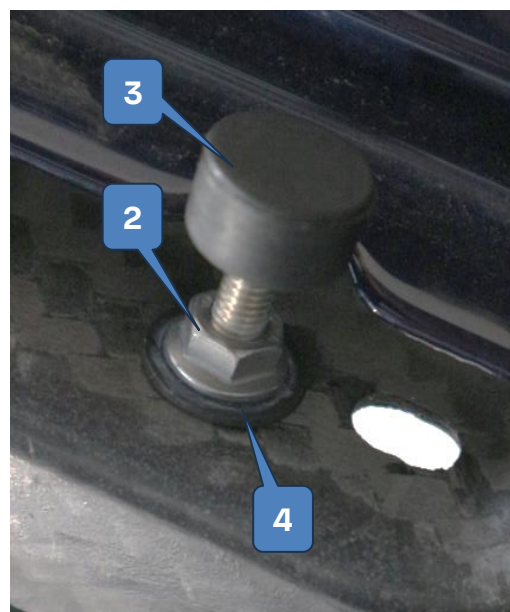
### OPERATION B Repair method:

**Information for the service network:**  
As part of the continuous monitoring of the product, Automobili Lamborghini S.p.A. requires the washers of the engine bonnet stoppers to be removed

1. Open the rear bonnet (1).
2. Loosen the nut (2).
3. Unscrew the stopper (3) gauge by removing it completely.
4. Remove washer (4).
5. Re-tighten the stopper (3) until the nut (2) is flush.
6. Before tightening nut (2), ensure that there is a distance of approximately 15 mm between its base and the bottom of stopper (3). Then, tighten nut (2) with a torque of 3.3 Nm.
7. Carry out the operation on all four stoppers.
8. Once the procedure is complete, close the engine bonnet (1) and check that it is aligned correctly. If it is not aligned correctly, adjust the four stoppers (3) until it is.
