Oil Leak at Vibration Damper Area

Topic number	LI01.40-N-077649
Version	5
Function group	01.40 - Crankcase, timing case cover, end cover
Date	9/10/25
Validity	Engine OM654
Reason for change	Part number A6540103216 added

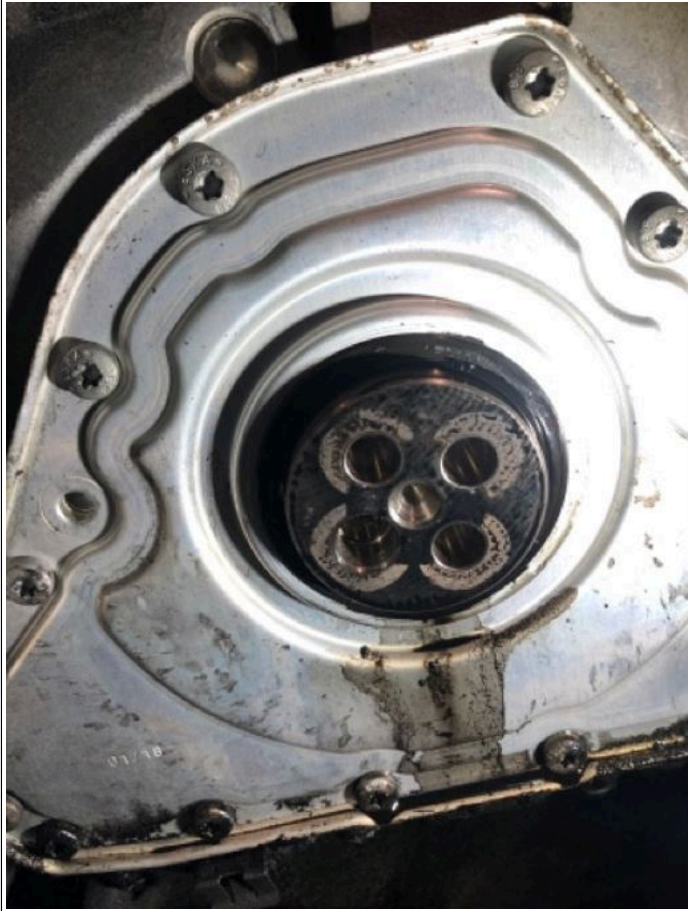
Oil leakage observed near the vibration damper, traced to a faulty radial shaft sealing ring at the front crankshaft flange. (see photo in attachment)

Attachments	
File	Description
Radialwellendichtring undicht.JPG	Leaky radial shaft sealing ring

Install a crankcase cover equipped with a design-optimized radial shaft sealing ring. This updated sealing ring features a revised lip structure that relocates the sealing surface outside the worn area of the crankshaft.

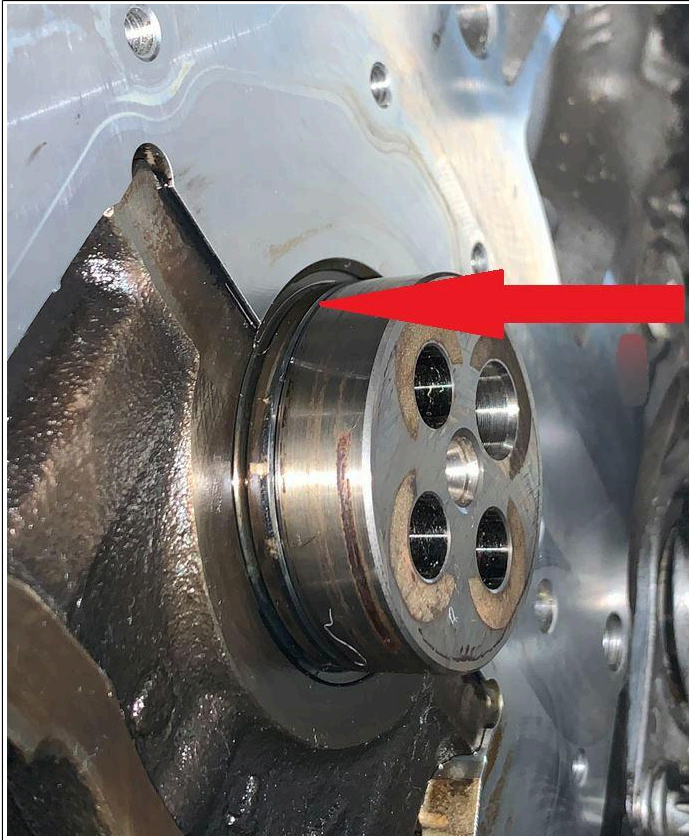
Verschleiß am Kurbelwellenflansch vorn.JPG

The sealing lip of the radial shaft sealing ring has worn a groove into the front crankshaft flange. This wear compromises the sealing integrity between the crankshaft and the radial shaft sealing ring in its original assembly position.

Wear on front crankshaft flange

No engine or crankshaft replacement is required when installing the updated crankcase cover with the optimized sealing ring.
