# Technical Service Bulletin

<b>Topic</b>	Sunroof blind not retracting   Bentleyga Series   17-26MY
<b>Market area</b>	Bentley: worldwide (2WBE),China 796 VW Import Comp. Ltd (Vico), Beijing (6796)
<b>Brand</b>	Bentley
<b>Transaction No.</b>	2078373/1
<b>Level</b>	EH
<b>Status</b>	Released for publishing
<b>Release date</b>	Sep 10, 2025

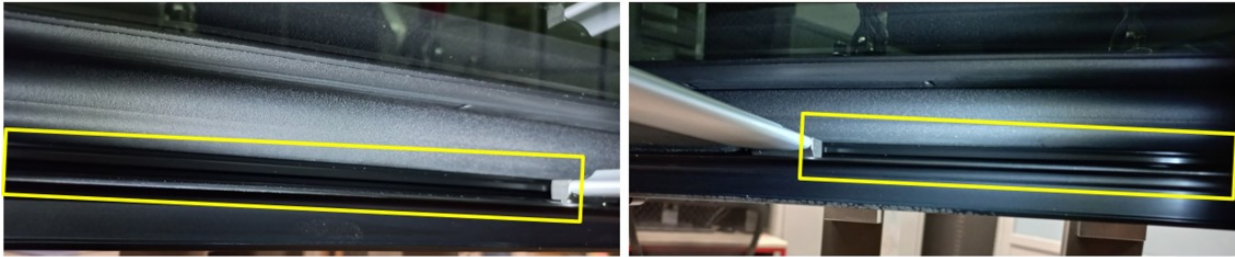
**Figure 1** Contamination of roof / guides for sunblind slide shoes

1. Inspect the sunroof blind frame for contamination of the guides (located under rear glass).
2. While the sunroof is stationary, visually inspect the rear section of the guide channels from underneath the rear glass. Check for small materials such as:
  - Small stones
  - Excessive dirt or dust
  - Organic matter (e.g., pine needles, leaves).

The guides must be completely clean and free from all contamination to ensure smooth operation.

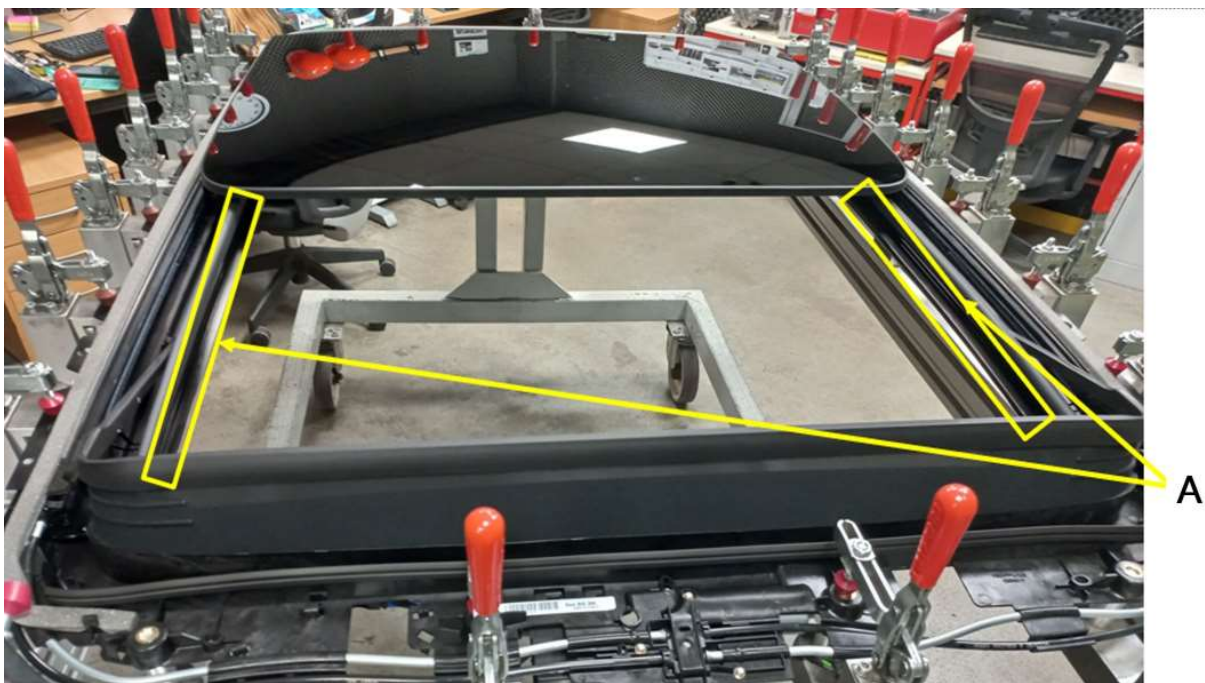
**Figure 2** Contamination of roof check

3. Inspect areas 'A' labelled in figure 2 of the frame for contamination.

The yellow markings highlight the area most likely to become contaminated when the roof is opened.

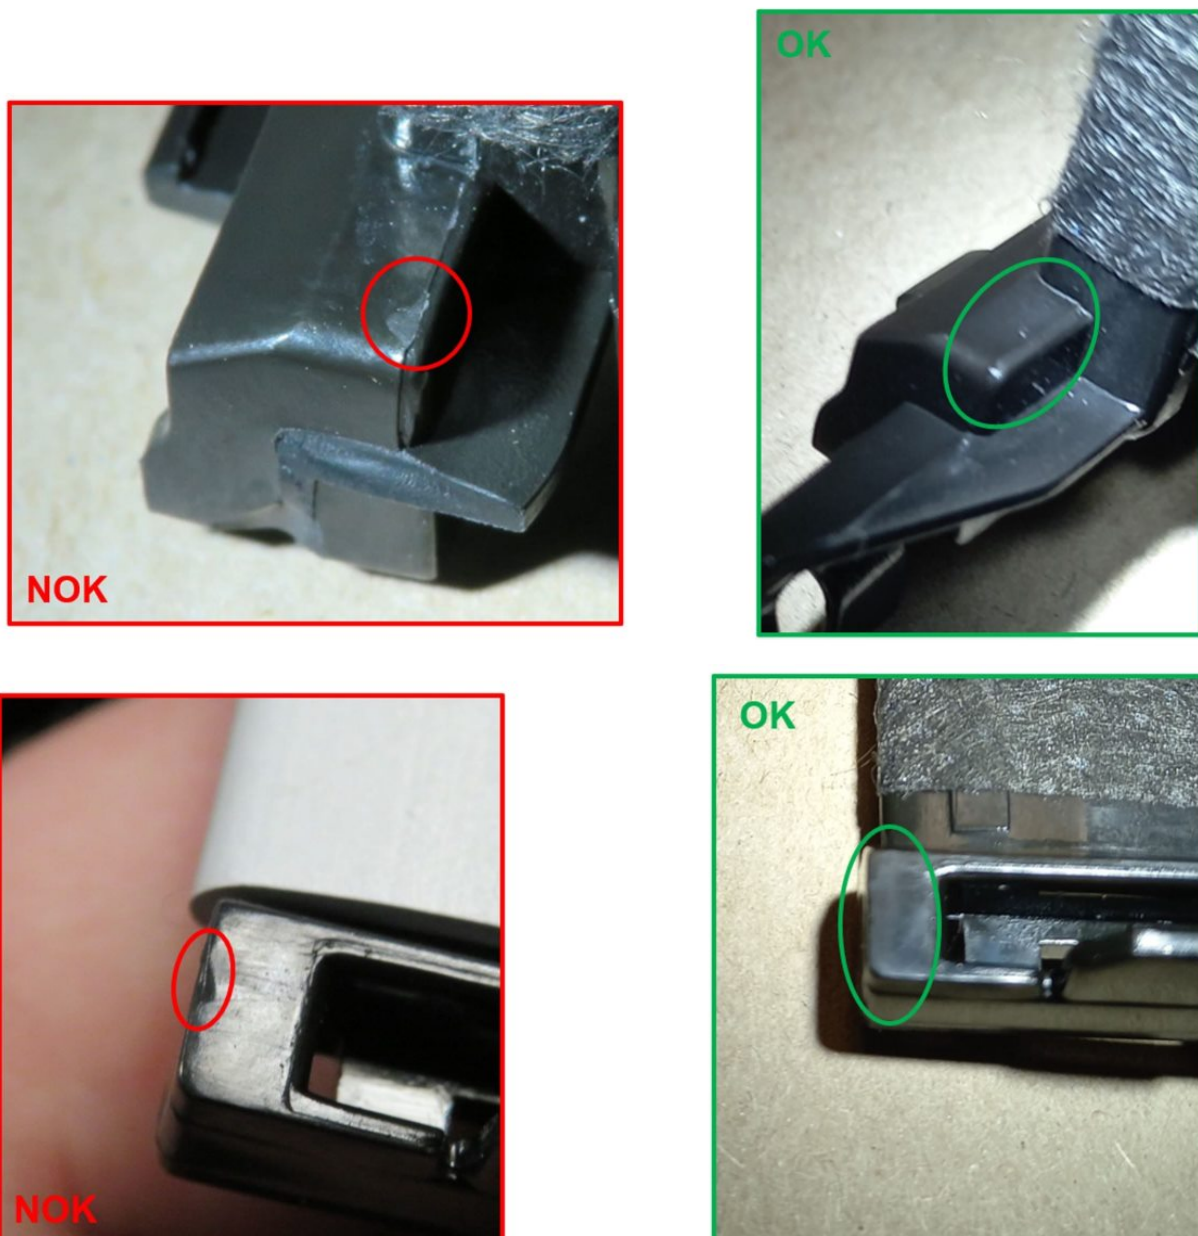
**Figure 3** Damage of the sunroof blind slide shoes due to contamination check

4. Inspect the sunroof blind slide shoes for:

- Cracks
- Wear
- Missing plastic components
- Distortion from misalignment.

All slide shoes must be intact and free of visible damage.

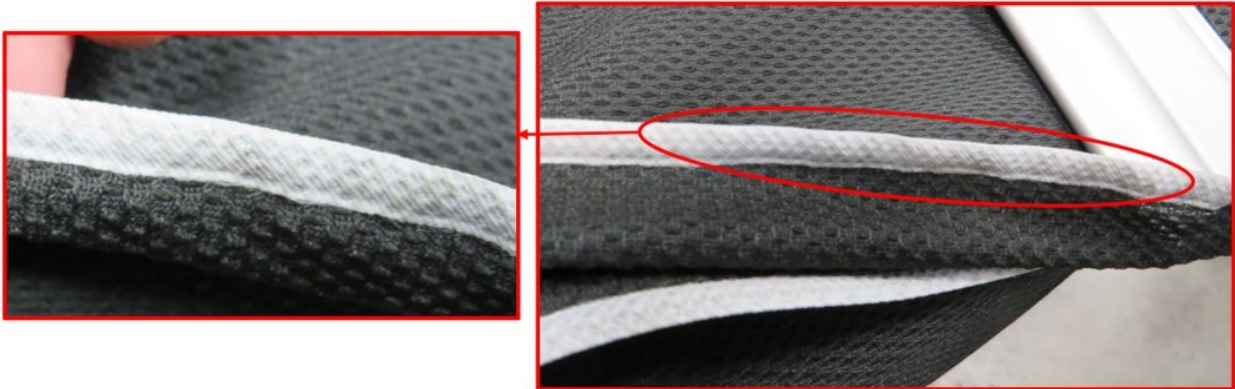
**Figure 4** Contamination of roof / PDF strip check

5. Inspect the PDF strip of the blind material, check for contamination on areas corresponding to the slide shoe path. If the guide is contaminated it is likely that the PDF strip is also contaminated or damaged.

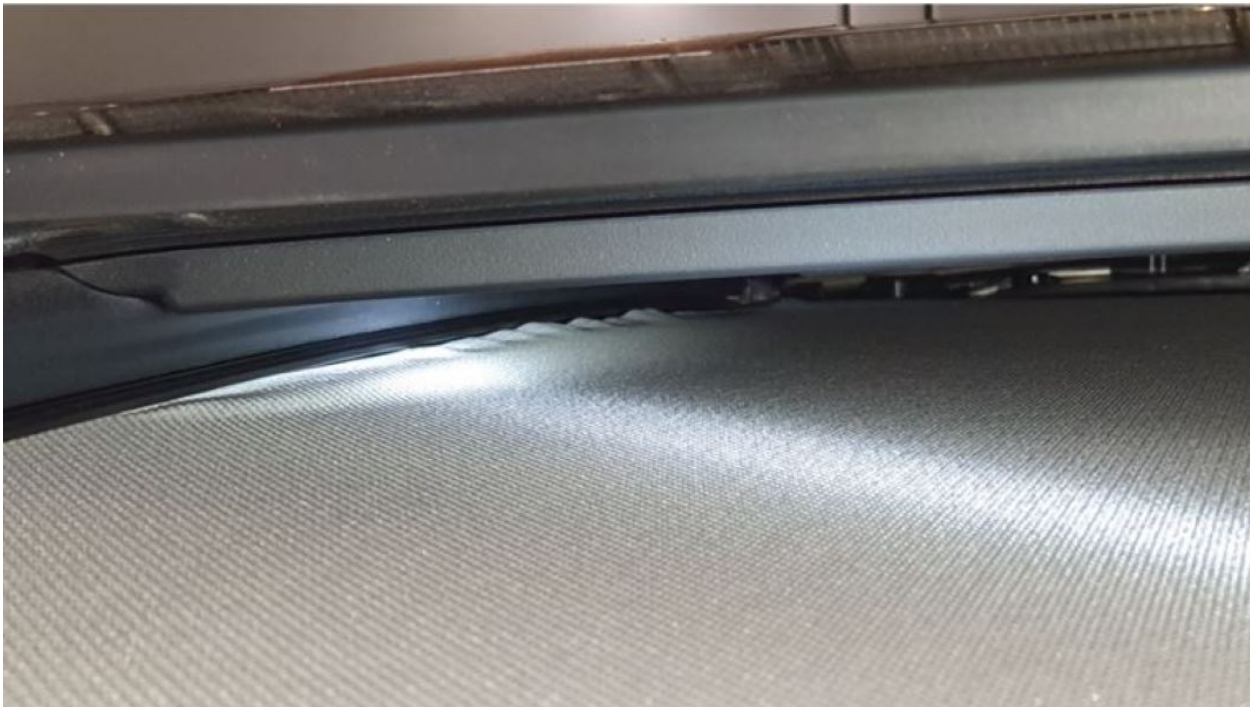
**Figure 5** PDF strip derailment check

6. Inspect the blind guides if they are coming off the runners and check the PDF strip for any derailing issue or NOK welding of the PDF strip.

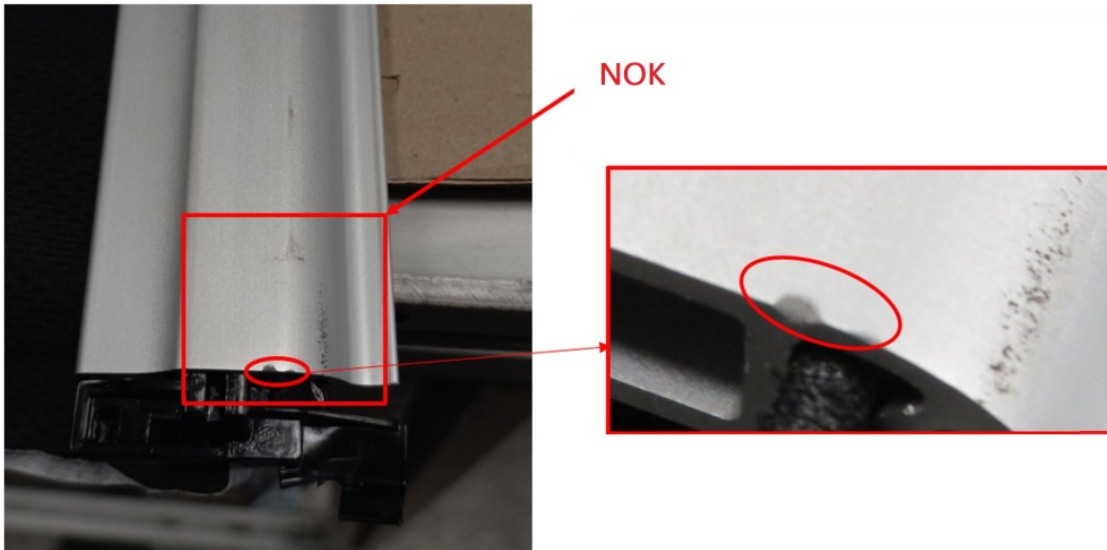
**Figure 6** Sunblind beam check

7. Inspect the sunblind beam for scratches or damage. Damage would indicate presence of external contamination.

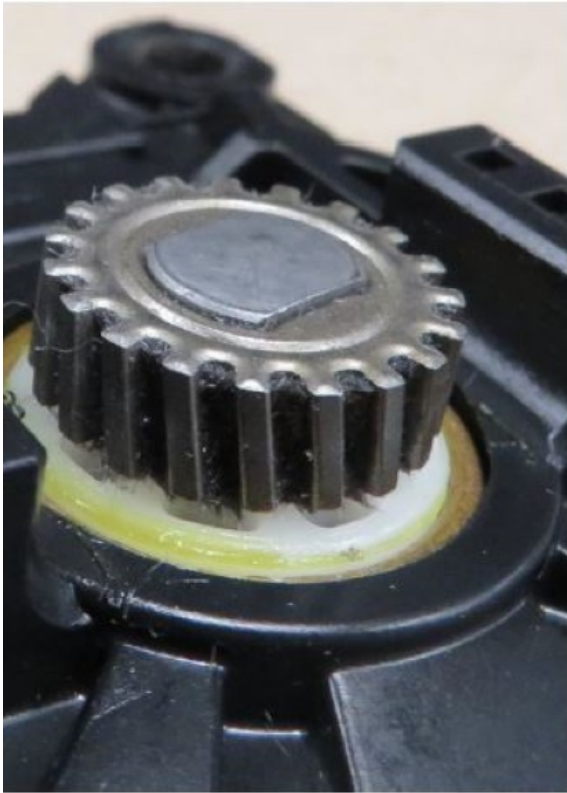
**Figure 8** Electric drive motor pinion inspection

9. Carefully inspect the motor unit pinion to confirm the presence and condition of fibre before proceeding.

**A build-up of fibres in the pinion drive gear can prevent sunroof blind operation**

10. While the motor is disengaged from the drive cables, run the motor to verify that it operates correctly in isolation. If the motor operates OK whilst removed; clean/remove fibres from the pinion/ drive gear.

11. Apply grease to the motor unit pinion and reassemble the motor to the sunroof blind.

**CARBAFLO® 2160 Perfluorinated High Temperature Grease must be used. Refer to the attached data sheet for the required grease specification.**
