Technical Service Bulletin

Topic	DTC P2EB700: 'Replace 12V Battery' stored in address 001 Continental GT/GTC/Flying Spur 25MY
Market area	Bentley: worldwide (2WBE),China 796 VW Import Comp. Ltd (Vico), Beijing (6796)
Brand	Bentley
Transaction No.	2079155/2
Level	EH
Status	Released for publishing
Release date	Sep 16, 2025

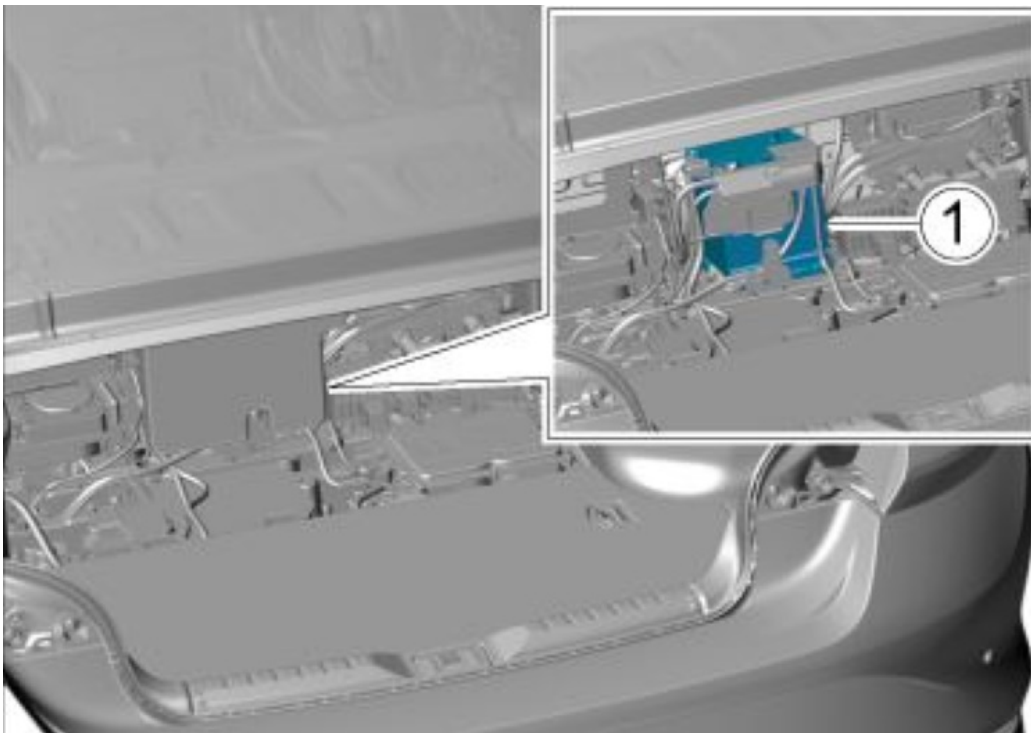
The Battery -1- is located in the boot, behind the subwoofer
