# Technical Service Bulletin

<b>Topic</b>	ODIS Error Message – Best Practice When Performing Baseline (BiL) Updates
<b>Market area</b>	Bentley: worldwide (2WBE),China 796 VW Import Comp. Ltd (Vico), Beijing (6796)
<b>Brand</b>	Bentley
<b>Transaction No.</b>	2078962/2
<b>Level</b>	EH
<b>Status</b>	Released for publishing
<b>Release date</b>	Sep 16, 2025

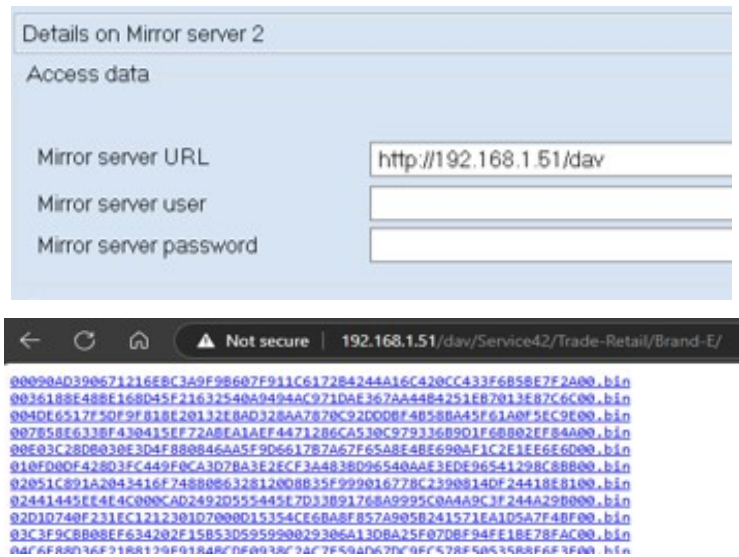
Mirror Server Settings

- Check that the URL in the Mirror Server 2 is correct for the new D3 edge box.
  - Refer to "Operating Modes" -> "Admin" -> "Connections" -> "Mirror Server 2;;.
- Ensure that the URL is http://.. And NOT https://
- Enter the mirror server URL into a web browser, and ensure that the flash files are visible on the server.
  - Copy & paste the Mirror server address into a web browser e.g Microsoft edge) -> Navigate to the flash files location: XXX.
