Technical Service Bulletin

Topic	DTC P0C4700 – Hybrid/High Voltage Battery Coolant Pump Continental GT/GTC/Flying Spur 25-26MY
Market area	Bentley: worldwide (2WBE),China 796 VW Import Comp. Ltd (Vico), Beijing (6796)
Brand	Bentley
Transaction No.	2079041/1
Level	EH
Status	Released for publishing
Release date	Sep 19, 2025

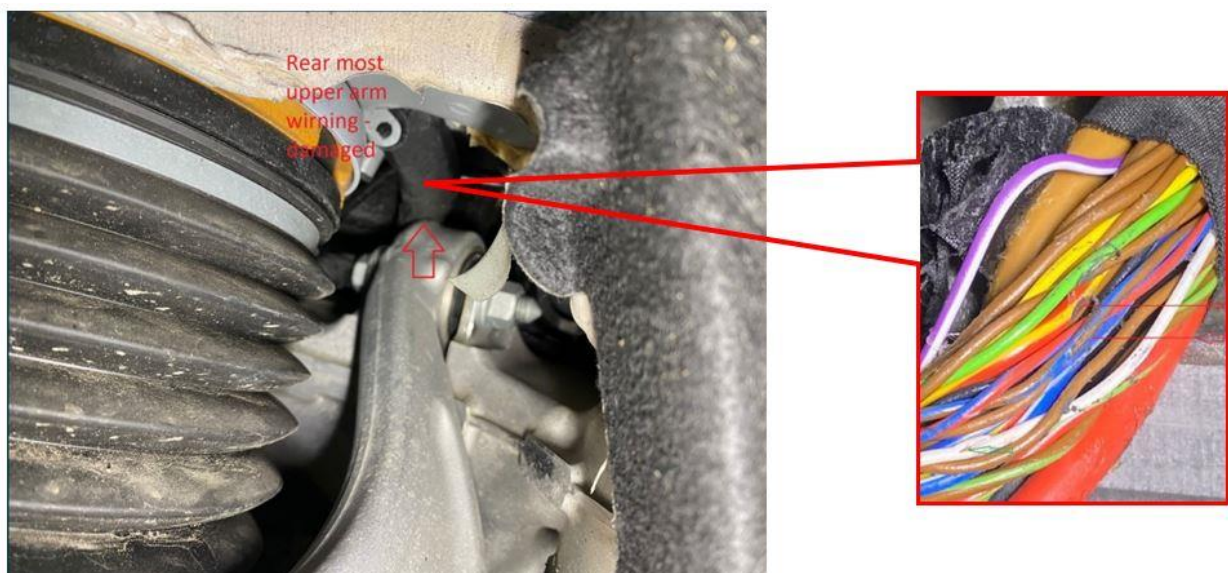
Figure 1. Wiring harness abrasion / chafing check

b. If the fuse is blown, check the circuit integrity from T8tw pin 5 to T14bp pin 10. Specifically look for chafing / abrasion of the wiring loom at the rear most upper suspension arm (Rear Left Suspension).

- c. Referring to ElsaPro Rep.Gr 97- Repair and insulate the wiring harness.
 - d. Replace the fuse (SE7-10A).
4. Check the connections at the relay J1156 (Located in the rear boot area with the label "646").
- a. Check all pins to the relay are secure
 - b. Check their drag and see if any are loose – If any issues are found repair accordingly.
5. Run a full diagnostic log and check If DTC's are present in 8C Battery Regulation Control unit.
- a. If any faults remain continue investigations.
 - b. If no faults remain, Conduct a short road test - Check to confirm issue is now resolved by driving the vehicle in EV Drive mode.
 - c. Raise a full technical ticket informing Bentley product support of the findings and release the car back the customer.
