Technical Service Bulletin

| Topic | Right and/or left hand front rearmost lower suspension lever inner hydraulic mount replacement guidelines |
| Brand | Bentley |
| Transaction No. | 2069493/4 |

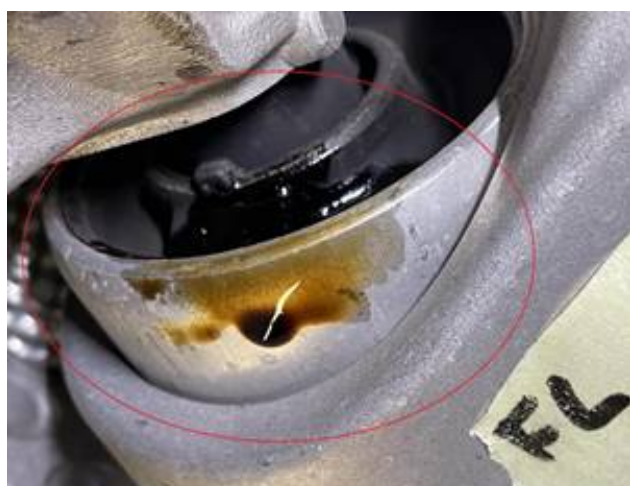
Figure 1

- If a leak is identified by the customer (Figure 1) - Replace the right and/or left hand front rearmost lower suspension lever inner hydraulic mounts as per all instructions within Rep.Gr 40

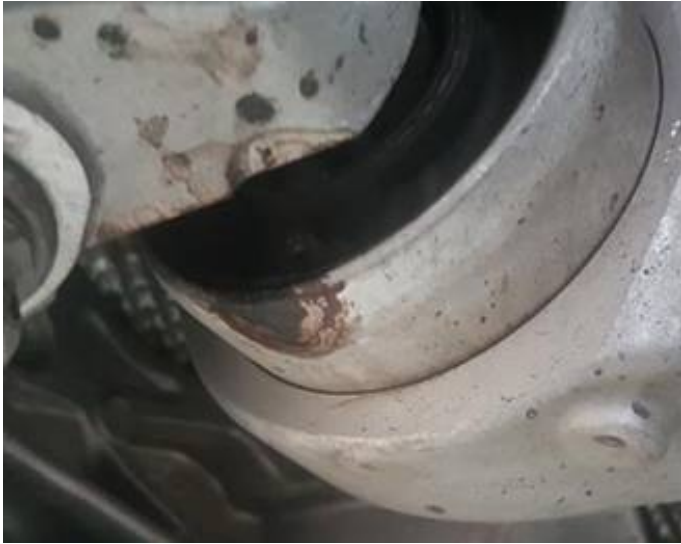
Figure 2

A dry oil stain mark (Figure 2) is evident on the right and/or left hand front rearmost lower suspension lever inner hydraulic mounts

Do not replace the hydraulic mounts

In the event a leak is spotted at service and no complaint of noise is received the operative should clean the affected area using a suitable cleaning agent do not replace the hydraulic mount in this scenario
