AMG HAG228 Rear Differential Oil Pan Leaking

| Topic number | LI35.31-P-079847 |
| Function group | 35.31 - Rear axle center assembly |

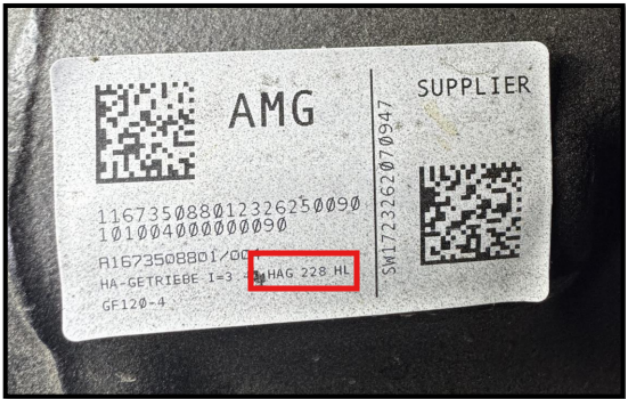
| Attachments | |
|---|---|
| <a href="#">Rear Differential Label.png</a> | Rear differential part label |

| <p>Example of differential label</p> | |

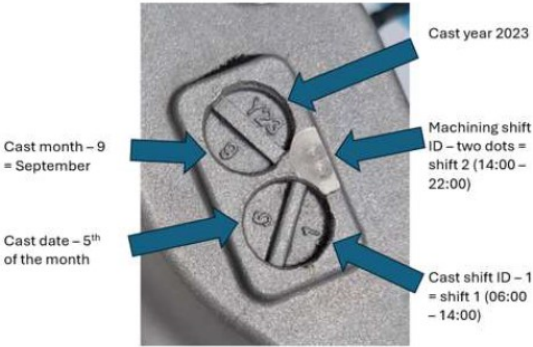
The supplier states this only affects rear differentials with 2023 production date. The production date can be found stamped on the housing cover (see attachment).

| <p><a href="#">Differential Cover Production Date.jpg</a></p> <p>Parts produced 2023 need to be checked</p> | <p>Rear differential production date stamp</p> |

- 1. Follow the attached instructions to inspect the rear differential cover for porosity.
- 2. Repair the vehicle with the applicable repair kit for the chassis.
- The new oil pans that come with the repair kit should be produced in 2024 and not have this issue.
