STAR ONLINE PUBLICATION

Case Number: S2523000081

Symptom/Vehicle Issue: Front Fascia Poor Fitment Popping Out From Headlamp Area.

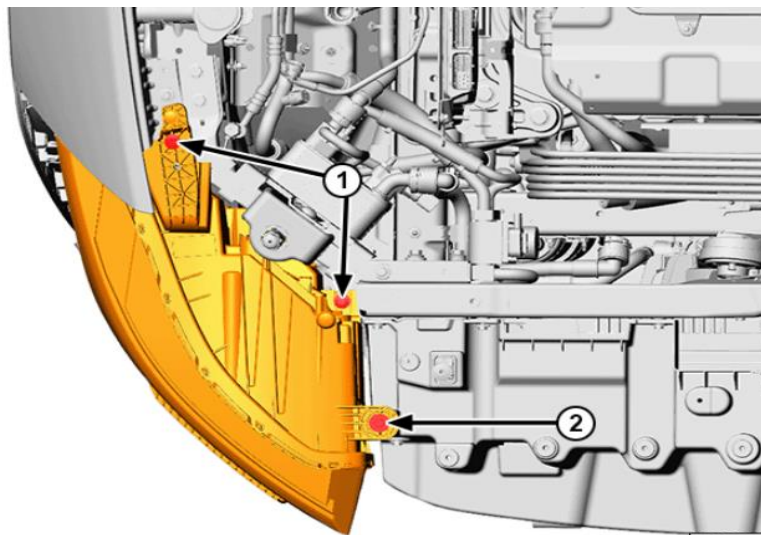
Discussion: If the front fascia has poor fitment or misalignment issue around the headlamp, the following adjustment can be used to improve fitment.

Refer to Service Library 08 - Electrical / 8L - Lamps and Lighting / Lamps/Lighting - Exterior / LAMP / Removal and Installation FRONT LAMP UNIT. It is not necessary to remove the lamp. Locate the top fasteners and loosen headlamp, push the lamp unit forward and engage with fascia bracket, then re-secure the headlamp.
