Technical Service Bulletin (TSB)
Vehicle No Start Condition

REFERENCE:	TSB: 08-104-25 REV. A GROUP: 08 - Electrical	Date:	September 30, 2025	REVISION:	08-104-25
VEHICLES AFFECTED:	**2024** - 2025 (LB) Dodge Charger This bulletin applies to vehicles built on or after **August 06, 2024 (MDH 0806XX) and on or before February 21, 2025 (MDH 0221XX)** equipped with 400V G2500 FR/RR Elec Drive Motors (Sales Code ELD).			MARKET APPLICABILITY: <input checked="" type="checkbox"/> NA <input type="checkbox"/> MEA <input type="checkbox"/> SA <input type="checkbox"/> IAP <input type="checkbox"/> EE <input type="checkbox"/> CH NOTE: **This bulletin applies to North America markets.**	
CUSTOMER SYMPTOM:	**Customers or technicians may experience one or more of the following:** <ul style="list-style-type: none"> • Vehicle will not start. • **wiTECH is unable to recognize and update the Electric Vehicle Control Unit (EVCU) software.** 				
CAUSE:	EVCU software issue

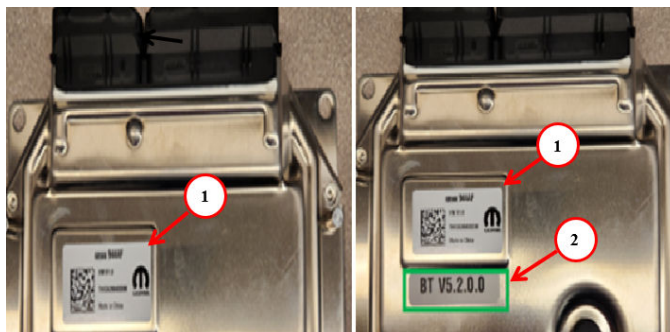
Fig. 1
EVCU Part Labels

1 - EVCU Part Number Label with 68566944AF - Replace EVCU

2 - EVCU Part Number Label with 68566944AF and Additional EVCU Label (BT V5.2.0.0 or V5.4.0.0 Label) - Do Not Replace EVCU

5. Is the part number on the label 68566944AF and no other label stating BT V5.2.0.0 or BT V5.4.0.0 is found on the EVCU [Fig. 1](#)?
 - YES>>> Proceed to [Step 8](#).

8. Replace the EVCU. Refer to the detailed service procedures available in DealerCONNECT/Service Library under: Service Info> 12 - Electrified Powertrain System / Electric Powertrain Control / Modules, High Voltage System / Removal and Installation.
