REFERENCE:	TSB: 08-153-25 REV. A GROUP: 08 - Electrical	Date:	September 30, 2025	REVISION:	08-153-25
VEHICLES AFFECTED:	<p>**2024** - 2025 (KM) Jeep Wagoneer S This bulletin applies to vehicles built on **or after August 15, 2024 (MDH 0815XX) and on** or before February 24, 2025 (MDH 0224XX) **equipped with a 400V G2500 FR/RR Elec Drive Motors (Sales Code ELD)**.</p>			<p>MARKET APPLICABILITY:</p> <p><input checked="" type="checkbox"/> NA <input type="checkbox"/> MEA <input type="checkbox"/> SA <input type="checkbox"/> IAP <input type="checkbox"/> EE <input type="checkbox"/> CH</p> <p>NOTE: **This bulletin applies to North America markets.**</p>	
CUSTOMER SYMPTOM:	<p>Customers may experience a Malfunction Indicator Lamp (MIL) illumination and the vehicle may exhibit/set one or more of the following Diagnostic Trouble Codes (DTCs):</p> <ul style="list-style-type: none"> ● C10F8-00 - Left Front Wheel Hub Disconnect Actuator Position Sensor Circuit Range/Performance. ● C10F9-00 - Right Front Wheel Hub Disconnect Actuator Position Sensor Circuit Range/Performance. ● P061B-00 - Internal Control Module Torque Calculation Performance. <p>Customers may also comment on one or more of the fo

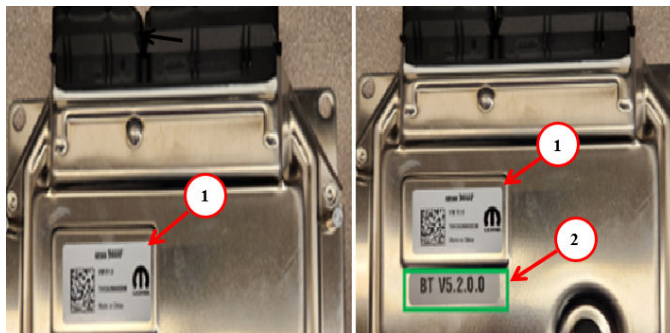
Fig. 1
EVCU Part Labels

1 - EVCU Part Number Label with 68566944AF - Replace EVCU
2 - EVCU Part Number Label with 68566944AF and Additional EVCU Label (BT V5.2.0.0 or V5.4.0.0 Label) - Do Not Replace EVCU

4. Is the part number on the label 68566944AF and no other label stating BT V5.2.0.0 or BT V5.4.0.0 is found on the EVCU [Fig. 1](#)?
 - YES>>> Proceed to [Step 6](#).
 - NO>>> Proceed to [Step 5](#). Use Inspection LOP (08-19-49-9D) to close the active RSU.
5. Install the storage bin. Refer to the detailed service procedures available in DealerCONNECT/Service Library under: Service Info> 23 - Body / Exterior / Bin, Storage / Installation.**
6. Replace the EVCU. Refer to the detailed service procedures available in DealerCONNECT/Service Library under: Service Info> 12 - Electrified Powertrain System / Electric Powertrain Control / Modules, High Voltage System / Removal and Installation.
7. ****Clear DTCs.****
