REFERENCE:	TSB: 08-302-25 REV. A GROUP: 08 - Electrical	Date:	October 1, 2025	REVISION:	08-302-25
VEHICLES AFFECTED:	2023 (W7) Jeep Grand Cherokee (INDIA) 2021 - 2023 (WL) Grand Cherokee / Grand Cherokee L (Australia) This bulletin applies to vehicles built equipped with one of the following radios: <ul style="list-style-type: none"> • Uconnect 5 Nav w 8.4" Display (Sales Code UPL). • Uconnect 5 Nav w 10.1" Display (Sales Code UPN). • Uconnect 5 Nav W 8.4" Display (Sales Code UUL). • Uconnect 5 Nav w 10.1" Display (Sales Code UUN). 			MARKET APPLICABILITY: <input type="checkbox"/> NA <input type="checkbox"/> MEA <input type="checkbox"/> SA <input checked="" type="checkbox"/> IAP <input type="checkbox"/> EE <input type="checkbox"/> CH NOTE: This bulletin applies to the India & Asia Pacific market.	
CUSTOMER SYMPTOM:	Customers may experience one or more of the following: <ul style="list-style-type: none"> • Temperature displayed in the radio display screen and rear HVAC are mismatched. • Auto door locks are inoperable.

CAUSE:	Software improvements

This bulletin involves inspecting and if required, updating the radio software level to U40.20. Depending on the radio's current softwar

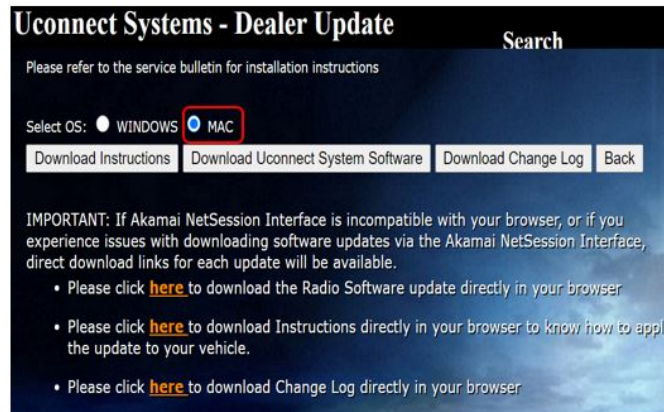
Fig. 1

MAC Download Steps

6. Download the software update file to your local PC's desktop. Make sure to select the “MAC” radial button for all downloads [Fig. 1](#).

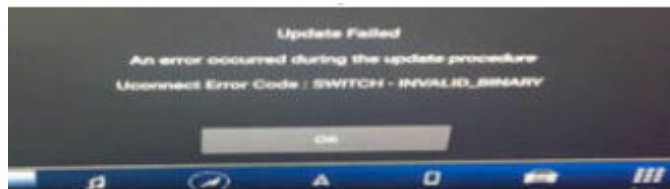
Fig. 6
Switch-Invalid_Binary Error

- NOTE:**
- Flash time will take ~30 minutes to one hour.
 - Vehicle should be running the entire time.
 - Sometimes the radio throws an error pop up "Switch-Invalid_Binary" after successful radio update. Please ignore this error and click OK [Fig. 6](#).
