REFERENCE:	TSB: 08-310-25 GROUP: 08 - Electrical	Date:	October 4, 2025	REVISION:	08-230-24
VEHICLES AFFECTED:	<p>**2021** - 2024 (WL) Jeep Grand Cherokee / Grand Cherokee L 2022 - 2024 (WS) Grand Wagoneer/Wagoneer This bulletin applies to vehicles built equipped with one of the following radios:</p> <ul style="list-style-type: none"> ● Uconnect 5 w 8.4" Display (USA) (Sales Code UBF). ● Uconnect 5 w 8.4" Display (CAN) (Sales Code UEF). ● Uconnect 5 Nav w 8.4" Display (USA) (Sales Code UBL). ● Uconnect 5 Nav w 8.4" Display (CAN) (Sales Code UEL). ● Uconnect 5 Nav w 10.1" Display (USA) (Sales Code UBN). ● Uconnect 5 Nav w 10.1" Display (CAN) (Sales Code UEN). ● Uconnect 5 Nav w 12.0" Display (USA) (Sales Code UBQ). ● Uconnect 5 Nav W 12.0" Display (CAN) (Sales Code UEQ). ● Uconnect 5 w 8.4" Display (MEX) (Sales Code UFF). ● Uconnect 5 Nav w 8.4" Display (MEX) (Sales Code UFL). ● Uconnect 5 Nav w 10.1" Display (MEX) (Sales Code UFN). ● Uconnect 5 Nav w 12.0" Display (MEX) (Sales Code UFQ). 			<p>MARKET APPLICABILITY:</p> <p><input checked="" type="checkbox"/> NA <input type="checkbox"/> MEA <input type="checkbox"/> SA <input type="checkbox"/> IAP <input type="checkbox"/> EE <input typ

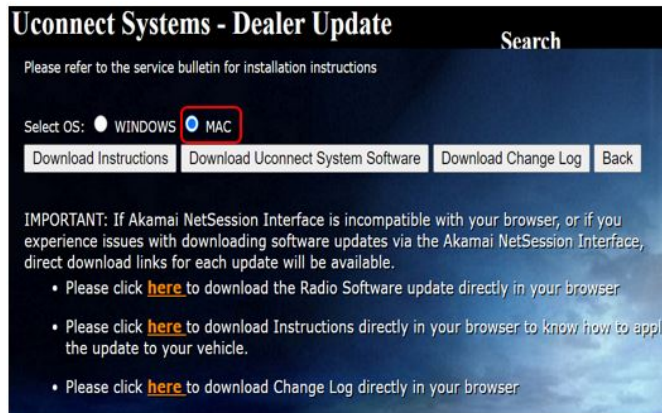
Fig. 1

MAC Download Steps

7. Download the software update file to your local PC's desktop. Make sure to select the "MAC" radial button for all downloads Fig. 1.

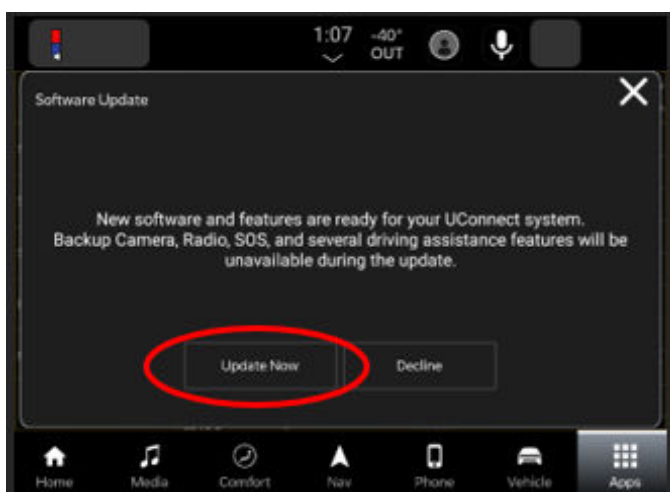
Fig. 2
Software Update Screen

14. Press Update Now [Fig. 2](#).

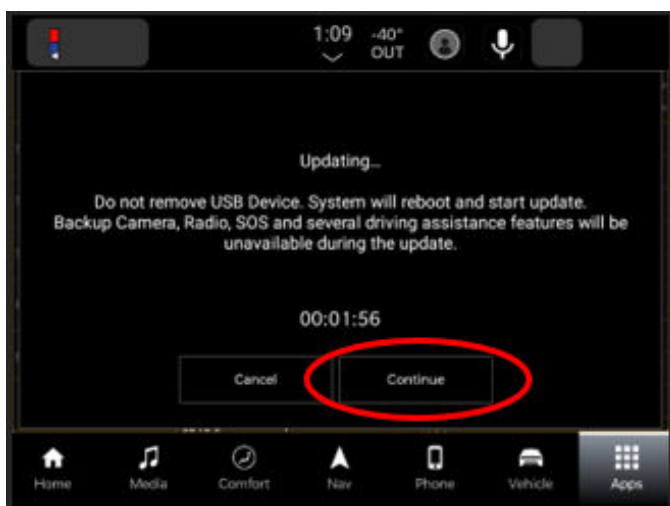
Fig. 3
Timer Screen

15. Press Continue [Fig. 3](#).

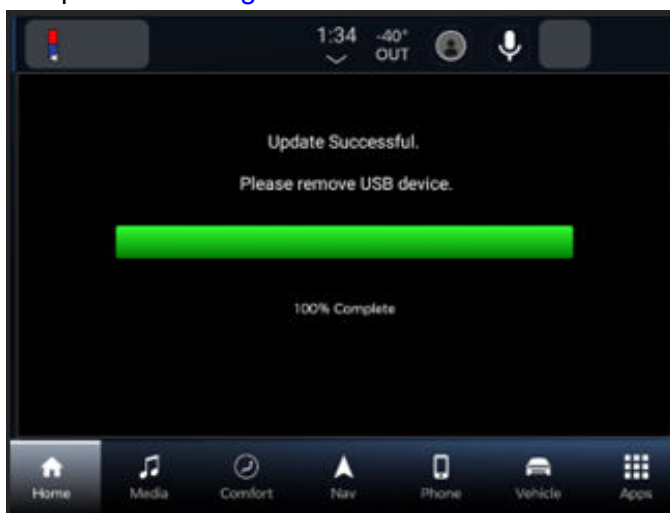
Fig. 4
Progress Screen

16. Wait for software update to complete 100% [Fig. 4](#).

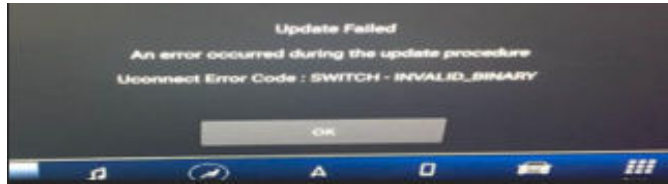
NOTE: Sometimes the radio throws an error pop up "Invalid_Binary_Switch" after successful radio update. Please ignore this error and click ok [Fig. 5](#).

Fig. 5
Invalid_Binary_Switch Error
