Technical Service Bulletin (TSB)

Aisin K1 Clutch/Input Shaft Assembly Replacement XW1 Warranty Extension

REFERENCE:	TSB: 21-041-25 GROUP: 21 - Transmission and Transfer Case	Date:	October 4, 2025	REVISION:	-
VEHICLES AFFECTED:	2022 (DD) RAM 3500 Cab Chassis 2022 (DP) RAM 4500/5500 Cab Chassis 2022 (D2) RAM 3500 Pickup This bulletin applies to vehicles built on or after June 05, 2022 (MDH 0605XX) on or before November 30, 2022 (MDH 1130XX) equipped with a 6SPD Auto Aisin AS69RC HD Transmission (Sales Code DF2) or a 6SPD Auto Aisin AS66RCHD Trans (Sales Code DF3).			MARKET APPLICABILITY: <input checked="" type="checkbox"/> NA <input type="checkbox"/> MEA <input type="checkbox"/> SA <input type="checkbox"/> IAP <input type="checkbox"/> EE <input type="checkbox"/> CH NOTE: This bulletin applies to the North America markets.	
CUSTOMER SYMPTOM:	Customers must experience a Malfunction Indicator Lamp (MIL) illumination and the vehicle must exhibit/set the following Diagnostic Trouble Code (DTC): <ul style="list-style-type: none"> ● P0731-00 - Gear 1 Shift Incorrect Ratio. <p style="text-align: center;">NOTE: This DTC will set during a key cycle and shifting into Drive.</p> Customers may

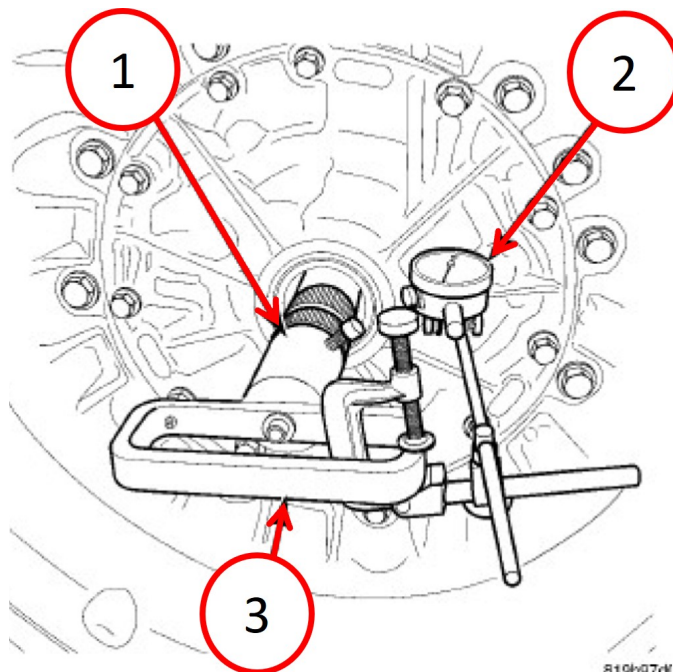
Fig. 3
Recording The Input Shaft End-Play

NOTE: Gear train end play is a critical pre-disassembly check to help determine the condition of the transmission. An end play reading greater than specification (larger gap) indicates that a bearing or thrust plate is either missing, worn or has disintegrated, in which case there will be debris found in the transmission oil pan.

- Using special tools Adapter Socket, End Play 8266-22 and the handle from End-Play Tool Set 8266B and Dial Indicator C-3339A, measure and record the input shaft end-play [Fig 3](#).

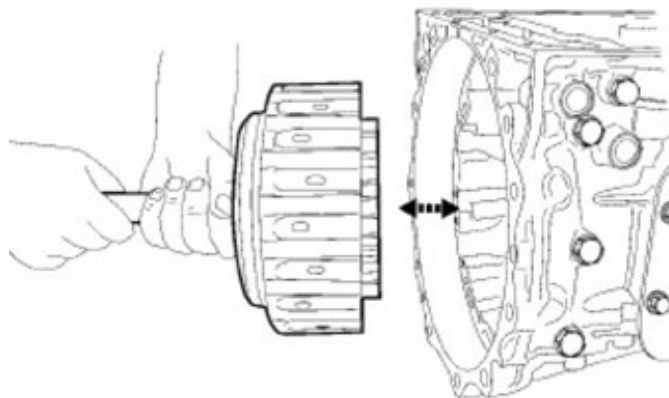
Fig. 6

NOTE: If the K1 snap ring has become dislodged, the K1 clutch assembly will not come out as a complete unit.

9. Remove the input shaft assembly with the K1 and K2 clutch assemblies attached [Fig. 6](#).

20. Install the K2 clutch assembly and the K1 clutch/input shaft assembly into the transmission case [Fig. 6](#).
