**Intermittent Warning Message "Power Button Faulty - Service Required" in the Instrument Cluster / Fault Memory Entry "B143C29" in the Rear-End Electronics Control Unit (65/25)**

Model Line: **Taycan (Y1A / Y1B / Y1C)**

Model Year: **As of 2020 up to 2025**

Concerns: **Start-stop switch (ignition release switch)**

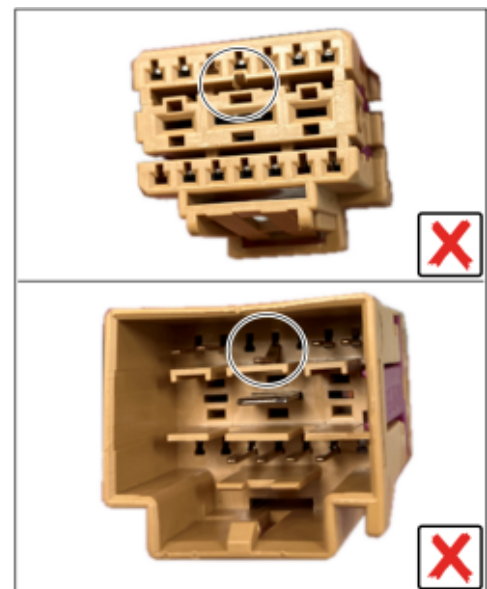
It is possible that pin 4 is bent at the electrical plug connection TCP.R.1A1 (disconnection point) **between the dashboard and main wire harness.**

*Bent pin with damaged plug housing*

**Therefore, before replacing the start-stop switch, the electric plug connection must be checked for bent pins, reworked if necessary or replaced if damaged. ⇒ Bent pin with damaged plug housing**

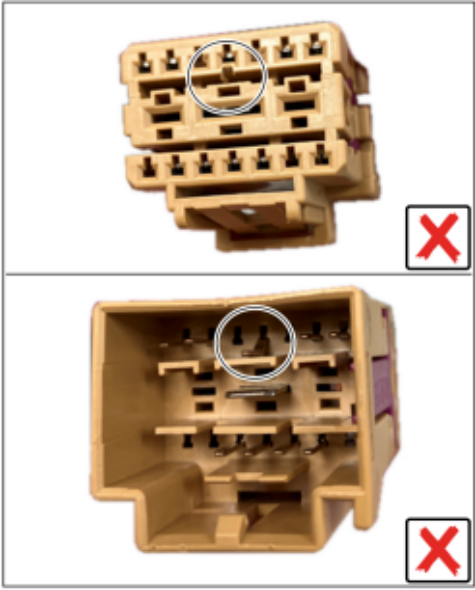
| Assessment | | Action |
|---|---|---|
| (✗) | <p>Plug housings are damaged or have bent pins.</p> <div data-bbox="493 693 964 1285"> </div> <p><i>Bent pin with damaged plug housing</i></p> | <p>The electrical plug connection is <b>not OK</b>.</p> <p>Repair the electrical plug connection.</p> <p>Then continue with Step ⇒ 5.</p> |
