Yellow Malfunction Indicator Light Comes On (Partially in Conjunction with Power Loss); Fault Memory Entries for the Exhaust Flap Position Element are Stored in the DME Control Unit (76/25)

Model Line: **911 (992)**

Model Year: **As of 2024 up to 2025**

Concerns: **Actuator for exhaust flap**

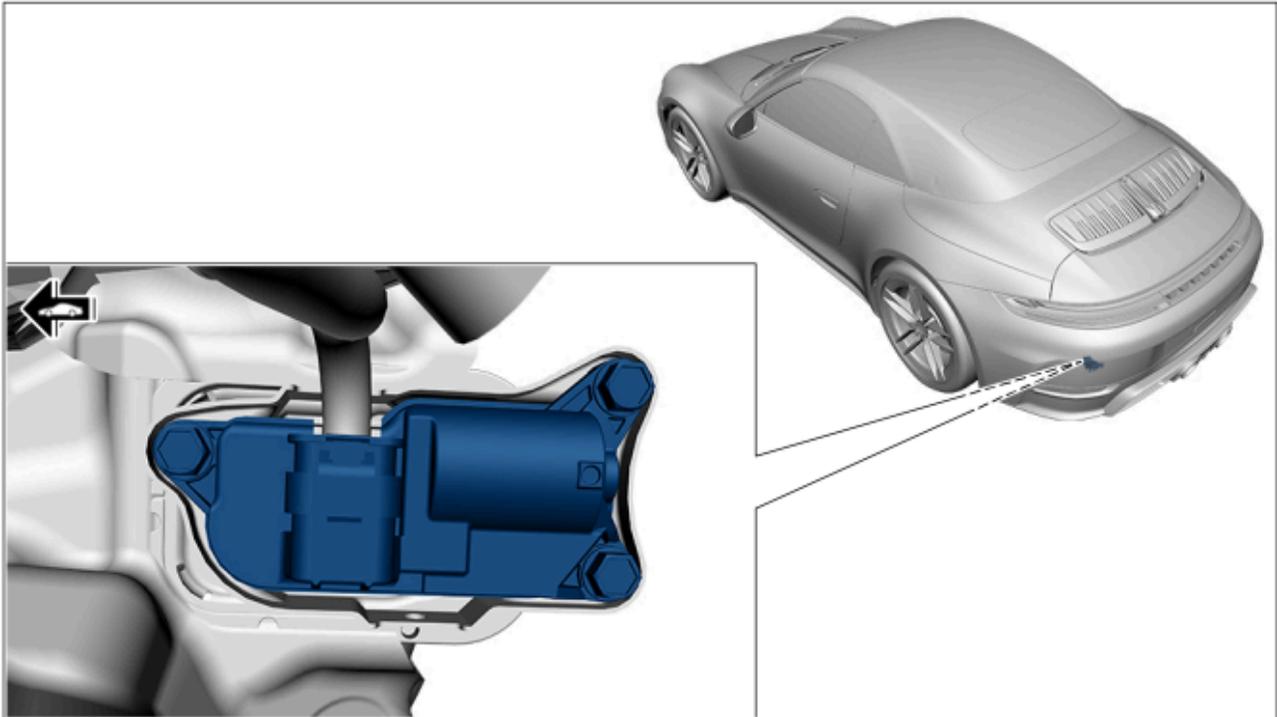
Installation location of exhaust flap actuator

Cause: The fault can occur due to accumulated moisture in the wire harness of the affected exhaust flap actuator.

Action: In the event of a complaint, replace the **affected** exhaust flap actuator **and** replace the corresponding wire harness.
