## J1- Measuring the Capacitance of High-Voltage Power Electronics

| Models | Model Year | Model Type | VIN Range | Vehicle-Specific Equipment |
|---|---|---|---|---|
| Taycan | As of 2020 up to 2024 | Y1A, Y1B, Y1C | N/A | Power Electronics |

**Bulletin #: 2519.1**

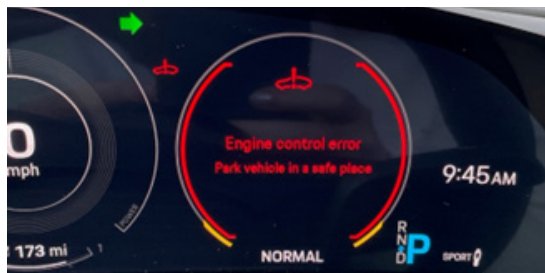
Customer complains of a red “Engine control error” in the instrument cluster (Figure 1). The workshop may find the following faults stored in the front and/or rear high-voltage power electronics CU and/or the DCDC Converter:

Figure 1  
“Engine control error” in instrument cluster”

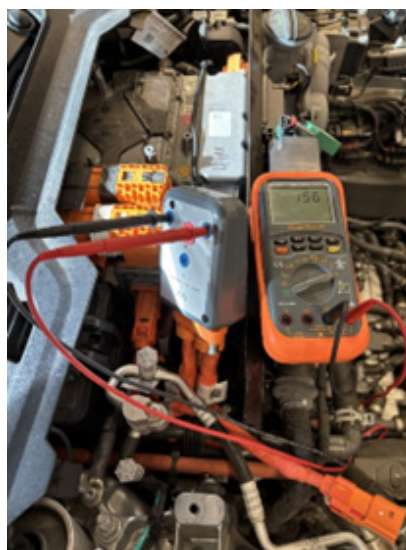
**Figure 3 - Measuring Capacitance  
on Front PE**

The power electronics (PE) may lose capacitance over time due to electrical fatigue. This results in voltage fluctuations in the HV system that can cause HV components to shut off in addition to the above-mentioned fault codes.

- d. Disconnect front HV PE traction cable connector (high-voltage connector).  
e. Install special tool VAS 6558A/38A-2 to front HV PE traction cable connector.  
f. Set multimeter to the capacitance measurement setting. Insert the red and black probes of the multimeter to the special tool leads labeled 1 and 2, respectively (Figure 3).  
g. Wait at least 10 seconds for the measurement to stabilize. Record the capacitance value once stabilized.  
h. Reinstall all components in reverse order.

3. Compare measurements to the chart below (Table 1). Replace any PE with a capacitance measurement that does not meet or exceed the lower tolerance limit. Please document the capacitance measurements in the PCSS job.
