TECHNICAL INSTRUCTIONS
FOR
CUSTOMER SUPPORT PROGRAM 22TE09
HV FLOOR UNDER WIRE HARNESS AND REAR TRACTION MOTOR CABLE
CORROSION
CERTAIN 2021 – 2024 MODEL YEAR VENZA HYBRID

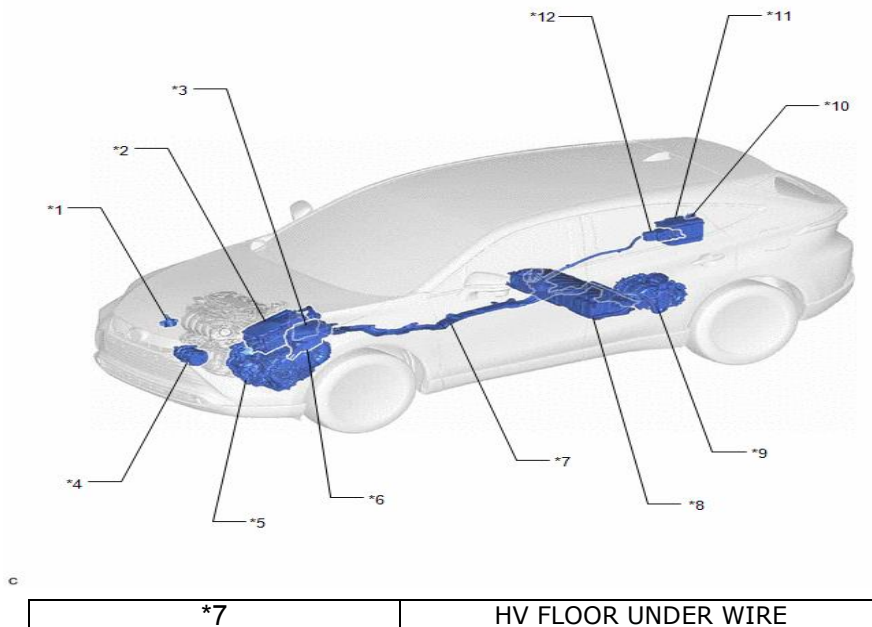
Although the HV Floor Under Wire Harness and Rear Traction Motor Cable is covered by Toyota's New Vehicle Limited Warranty for 3 years or 36,000 miles (whichever comes first), we at Toyota care about the customers' ownership experience. Toyota is providing coverage for repairs related to excessive corrosion to the wire harness connections at the Rear Motor Generator. Excessive corrosion can cause AM Radio Static during certain drive cycles or the vehicle may not start.

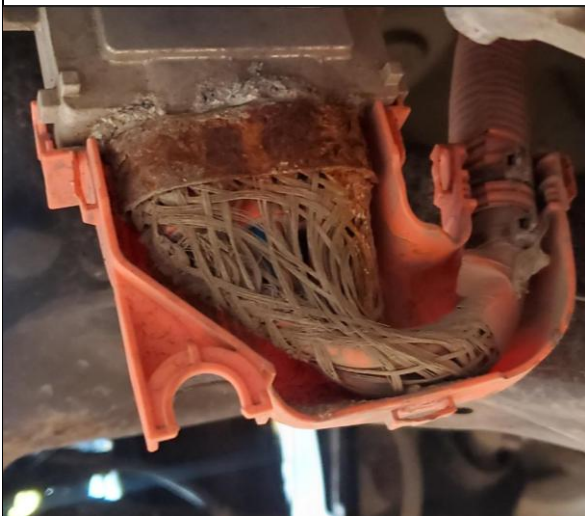
Y6 connector under the vehicle at MGR

- 5) **Inspect the Y6 connection for corrosion**
 f) Disconnect the Y6 connector at the MGR and inspect for corrosion, dirt, or debris.

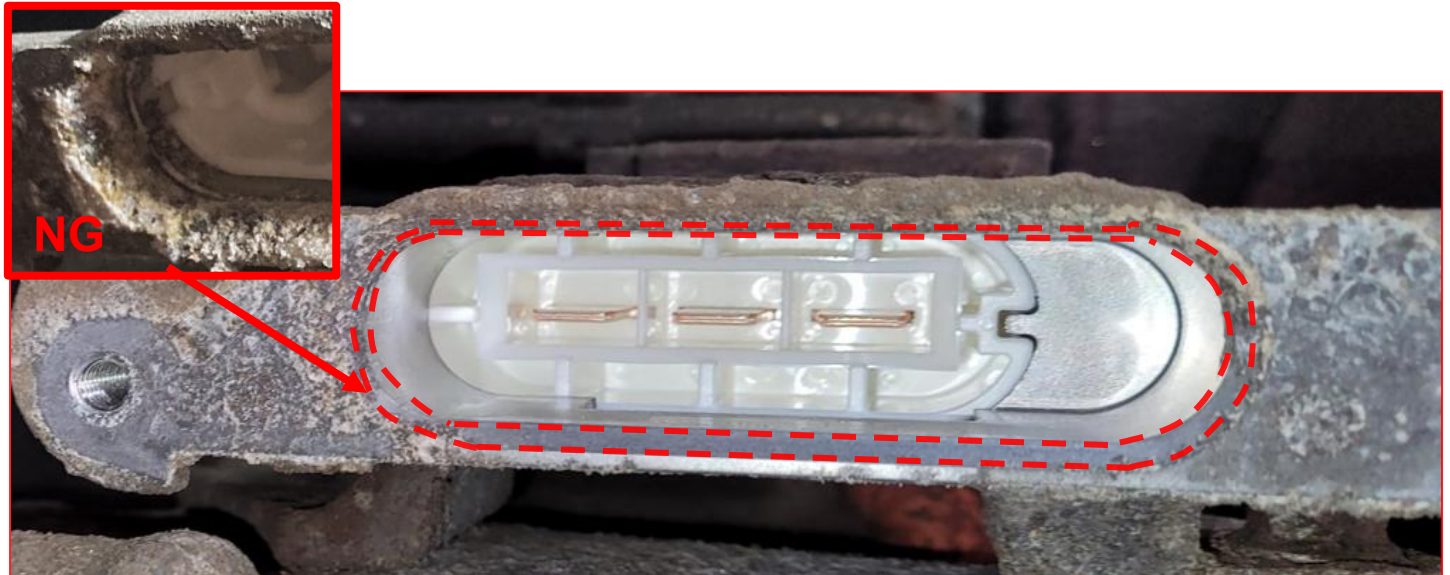
- a) Inspect the chamfer of the MGR connector housing for pitting and corrosion on the sealing surface. Corrosion in this area will cause the seal to leak. Are pitting and corrosion present?

YES – Rear Traction Motor Cable requires replacement continue to Section VI.
