TECHNICAL INSTRUCTIONS
FOR
CUSTOMER SUPPORT PROGRAM 22TE09
HV FLOOR UNDER WIRE HARNESS AND REAR TRACTION MOTOR CABLE
CORROSION
CERTAIN 2021 – 2024 MODEL YEAR RAV4 PRIME

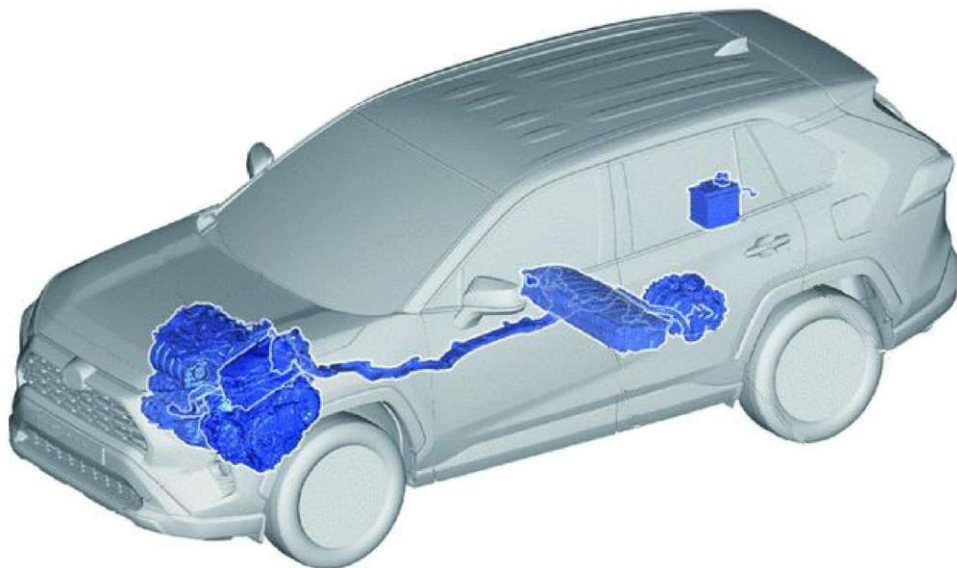
Although the HV Floor Under Wire Harness and Rear Traction Motor Cable is covered by Toyota's New Vehicle Limited Warranty for 3 years or 36,000 miles (whichever comes first), we at Toyota care about the customers' ownership experience. Toyota is providing coverage for repairs related to excessive corrosion to the wire harness connections at the Rear Motor Generator. Excessive corrosion can cause AM Radio Static during certain drive cycles or the vehicle may not start.

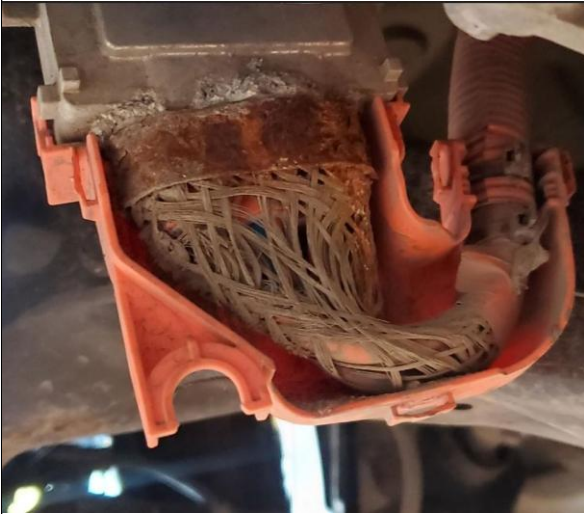
Y6 connector under the vehicle at MGR

- 5) Inspect the Y6 connection for corrosion
f) Disconnect the Y6 connector at the MGR and inspect for corrosion, dirt, or debris.

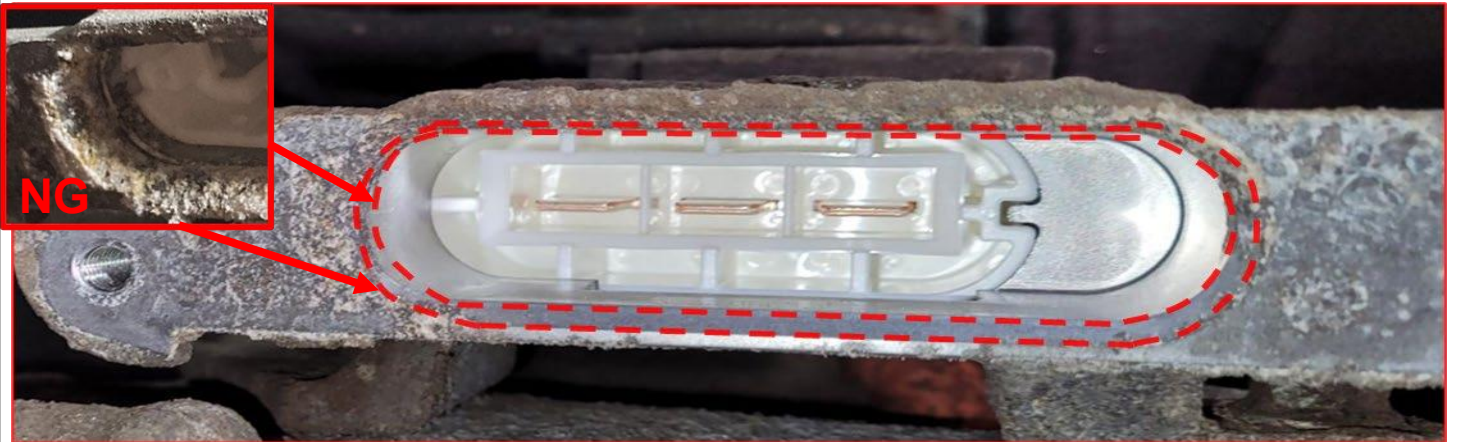
- a) Inspect the chamfer of the MGR connector housing for pitting and corrosion on the sealing surface. Corrosion in this area will cause the seal to leak. Are pitting and corrosion present?

YES – Rear Traction Motor Cable requires replacement continue to Section VI.
