CUSTOMER SUPPORT PROGRAM 22TE09

**HV FLOOR UNDER WIRE HARNESS AND REAR TRACTION MOTOR CABLE
CORROSION**

**CERTAIN 2022-2024 MODEL YEAR NX450H+
&
CERTAIN 2022-2024 MODEL YEAR RX450H+**

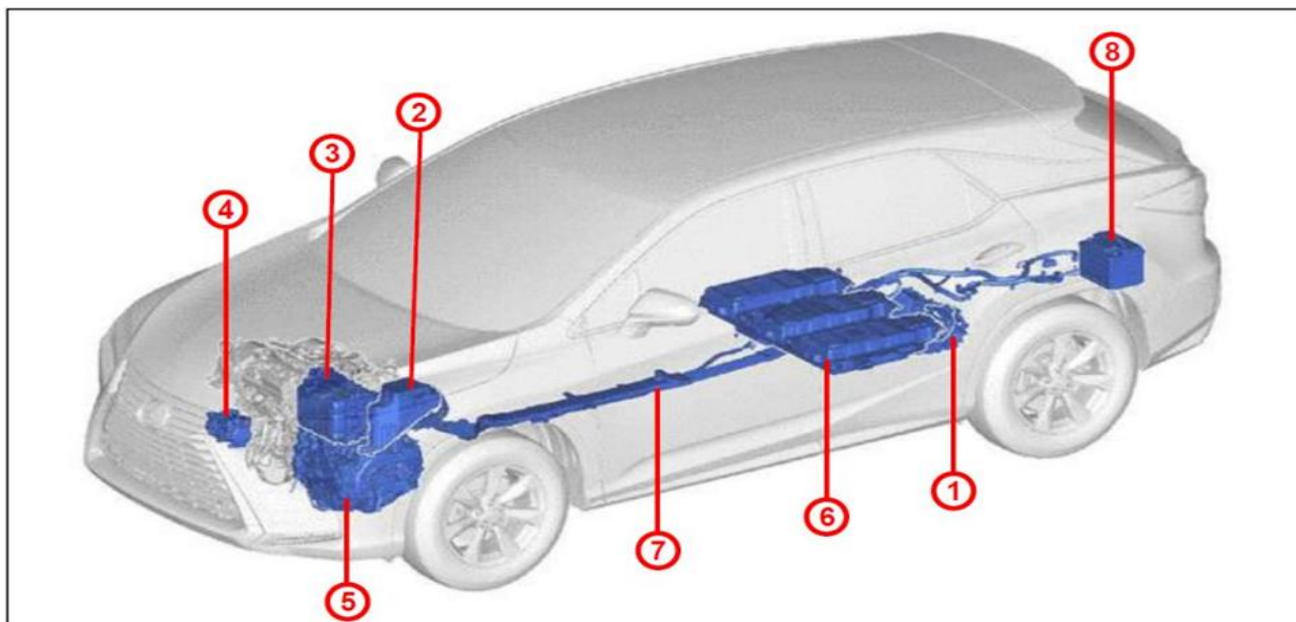
Although the HV Floor Under Wire Harness and Rear Traction Motor Cable is covered by Lexus's New Vehicle Limited Warranty for 3 years or 36,000 miles (whichever comes first), we at Lexus care about the customers' ownership experience. Lexus is providing coverage for repairs related to excessive corrosion to the wire harness connections at the Rear Motor Generator. Excessive corrosion can cause AM Radio Static during certain drive cycles, or the vehicle may not start.

1	Rear Traction Motor with Transaxle Assembly	5	Hybrid Vehicle Transaxle Assembly
2	Engine Room Relay Block and Junction Block Assembly	6	HV Battery
3	Inverter with Converter Assembly	7	HV Floor Under Wire
4	Compressor with Motor Assembly	8	Auxiliary Battery

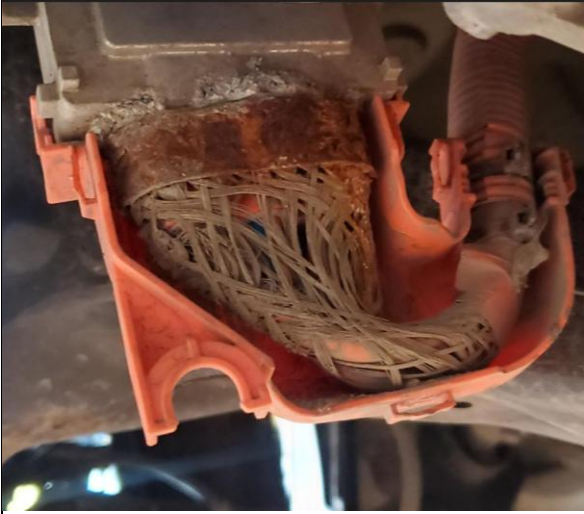
Y6 connector under the vehicle at MGR

- 5) Inspect the Y6 connection for corrosion
 - f) Disconnect the Y6 connector at the MGR and inspect for corrosion, dirt, or debris.

YES – Continue to Section VI.

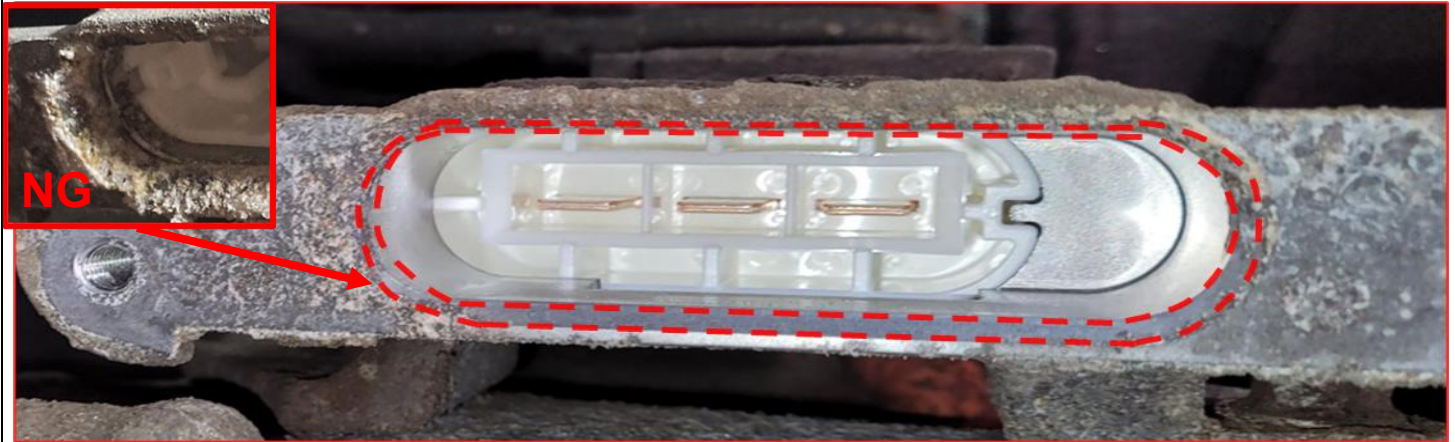
6) Inspect the connector housing of the MGR

- a) Inspect the chamfer of the MGR connector housing for pitting and corrosion on the sealing surface. Corrosion in this area will cause the seal to leak. Are pitting and corrosion present?

YES – Rear Traction Motor Cable requires replacement continue to Section VI.
