# ◀ IMPORTANT UPDATE ▶

CUSTOMER SUPPORT PROGRAM 23LE05

Certain 2022- 2024 Model Year NX350h  
Certain 2022- 2024 Model Year NX450h+  
Certain 2023- 2024 Model Year RX350h  
Certain 2024 Model Year RX450h+  
Coverage for High Voltage Floor Under Wire Harness and Rear Traction Motor Cable Corrosion

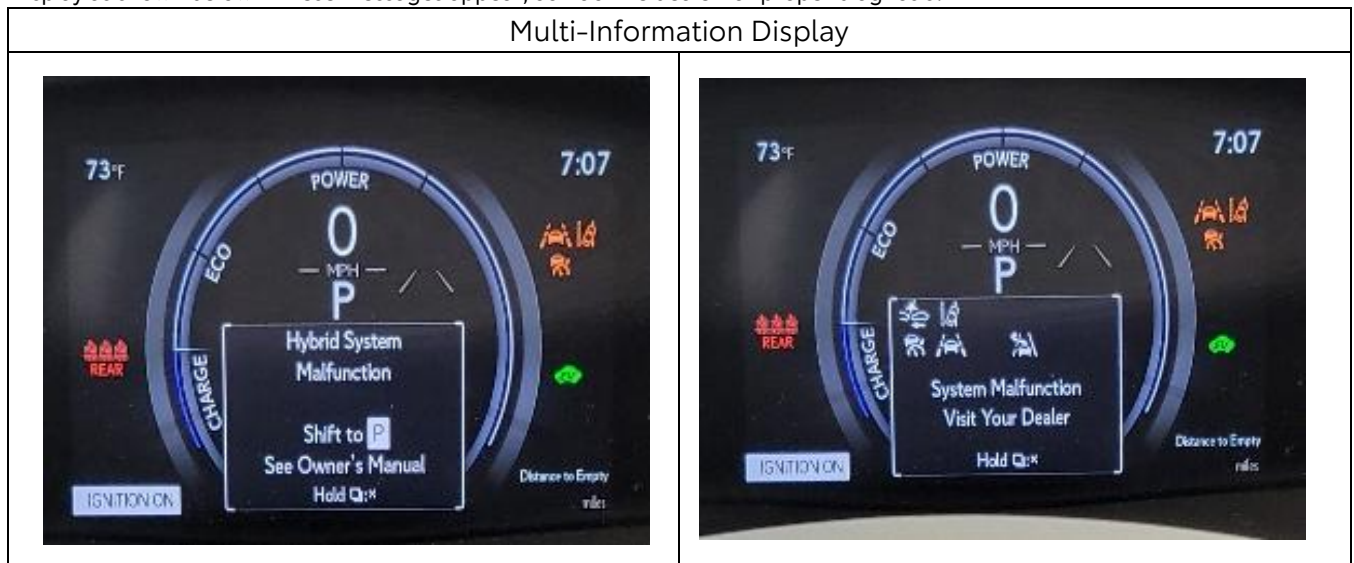
A3: If your vehicle detects a hybrid system issue, you may have messages displayed on the Multi-Information Display or the Head Unit Display as shown below. If these messages appear, contact the dealer for proper diagnosis.

Note: It is possible for the lights above to be illuminated and not be related to the condition outlined in this Customer Support Program.
