## Failure of One or More Surround View Cameras in the PCM Central Display

**Bulletin #: 2517.2**

Part ID: 9102

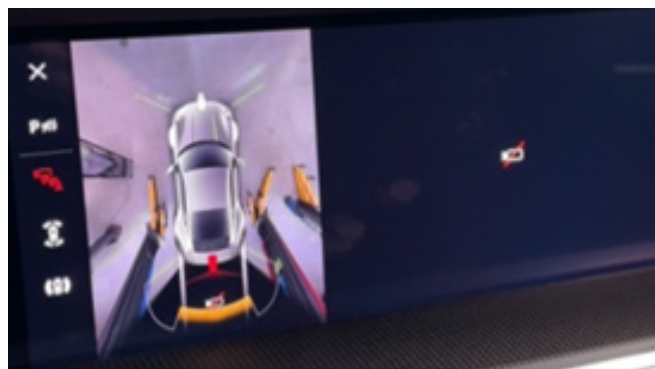
Figure 1

The customer complains about a sporadic, partial, or complete failure of the Surround View in the PCM Central Display. In addition, one or more of the fault memory entries listed below are stored in the control unit for assistance systems.
