### Y1A, Y1B, Y1C- High-Voltage (HV) Battery B1D9\*\*\* - Cell module x, aging detected

**Bulletin #: 2523**

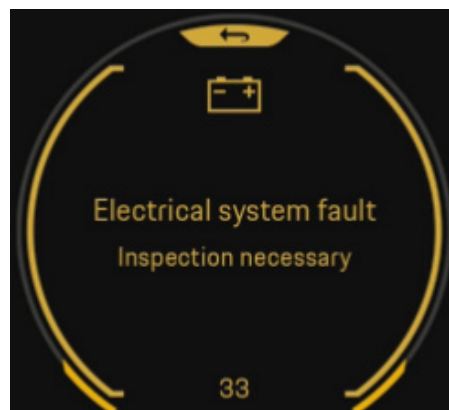
Figure 1

After updating the HV battery control unit (BMC) SW as part of the ARB6/7 recall campaigns, customers may complain of a yellow warning message “Electrical system fault Inspection necessary” on each vehicle start up shown in figure 1. The vehicle can still be driven in the presence of this warning, but control unit **automatically limits the maximum charging capacity to 80%** to reduce the risk of a short circuit in the battery.

During diagnosis, the workshop finds one or more fault memory entries titled “**B1D9\*\*\*- cell module x, ageing detected**” in the high-voltage battery control unit. In the fault code, the character \* can represent various numbers (1–9) or letters (A–Z). Each of these characters identifies a specific battery module. At point x in the fault title, the number of the affected battery module is specified.

The new HV battery software (1606 or 1652 depending on model year) performs a more thorough self-diagnosis routine to detect early cases of cell failures in each module. These faults set for specific cell failures and should not be treated as sporadic software faults that need to be cleared and reproduced to verify the failure. Maximum SoC of the entire battery will be limited to 80% as long as this warning is present.

If any of these faults are present, even without the yellow warning shown above, send a ticket to PCNA technical support to begin further diagnosis for HV battery repair. If a repair is not completed within 180 days, the max SoC limitation will automatically reduce from 80% to 50%.
