WSJ1 - Replacing Lid for Closing Aid Motor (Workshop Campaign)

Model Line: **Macan (XAB)**

Model Year: **As of 2024 up to 2026**

Concerns: **Lid for closing aid motor**

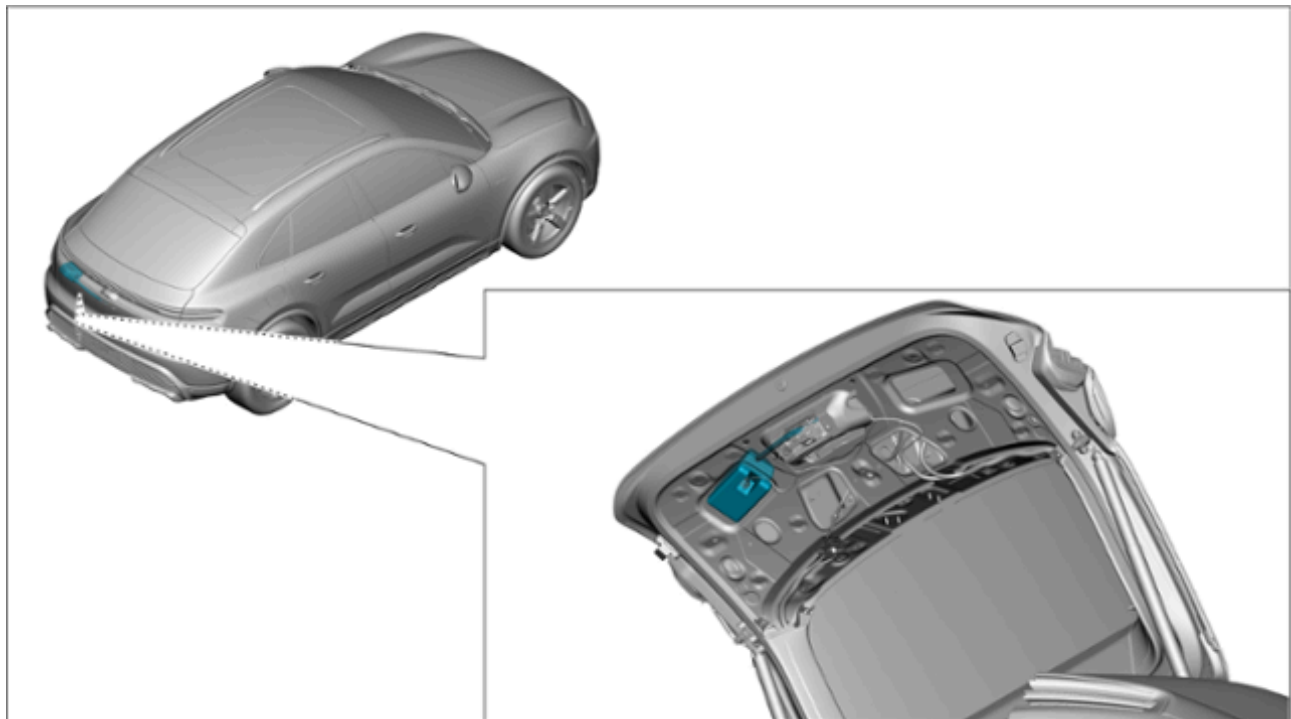
Installation position of lid for closing aid motor
