95B.III – Macan Rear Lid Does Not Open/Close

Vehicles Affected

Models	Model Year	Model Type	VIN Range	Vehicle-Specific Equipment
Macan	As of 2023 up to 2026	95B	N/A	N/A

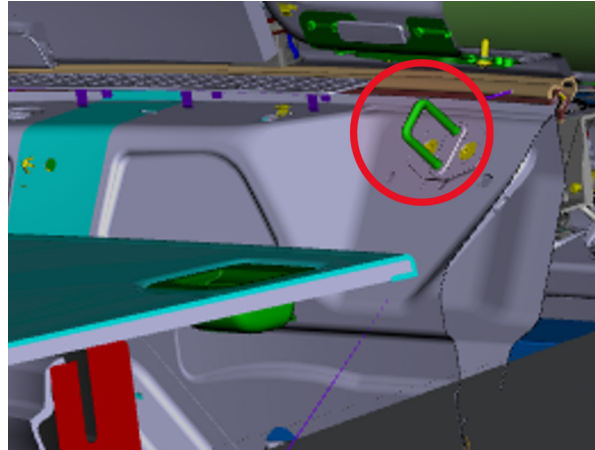
Figure 1 - Rear locking bar (Circled)

The customer states the rear lid does not fully close when contacting the lower latching bar (also referred to as the striker plate, see Fig. 1, below). In these cases, the tailgate can remain slightly open or begin to reopen while emitting a warning sound even if there is no obstruction.

The condition described above can occur if the placement of the locking bar in the 95B.III Macan is set too high causing contact too soon (See Figure 1).
