GROUP	MODEL
ENG	2023MY Sportage (NQ5, NQ5a) w/Theta III 2.5L GDI
NUMBER	DATE
259	October 2025

TECHNICAL SERVICE BULLETIN

ITM REPLACEMENT AND ECM

LOGIC IMPROVEMENT (CA2509)

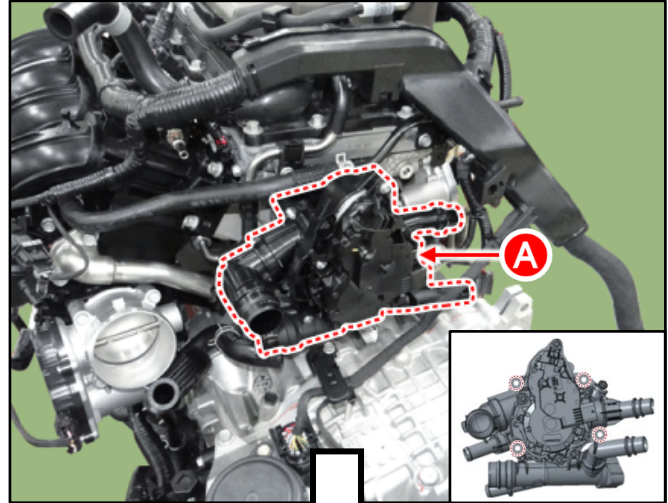
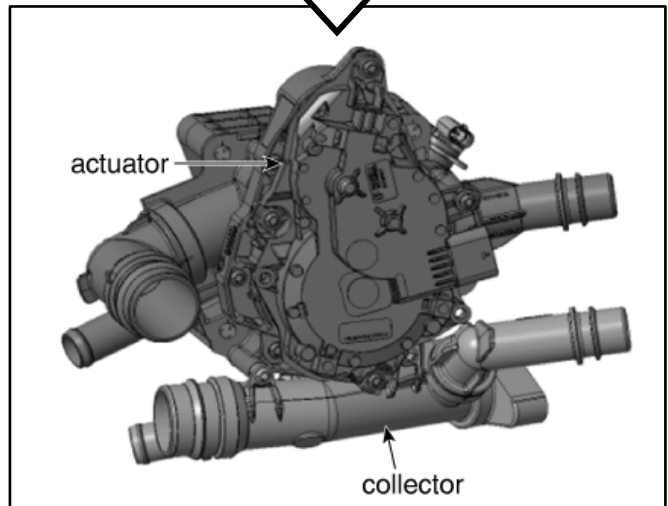
1. Replace the Integrated Thermal Management Module 'ITM' (A) by referring to "Engine Mechanical System → Cooling System → Integrated Thermal Management Module (ITM) → Repair procedures" in the applicable Shop Manual on KGIS.

Tightening torque for bolts:
7.2 - 8.7 lb.ft (9.8 - 11.8 N.m)

Do NOT disassemble the actuator and collector. The new ITM is supplied as an assembly unit.

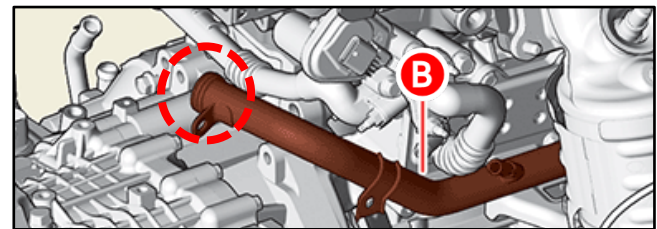
2. Reinstall all removed parts in reverse order of removal.
3. Install a new inlet pipe (B) O-ring on the red circled area shown.
4. Proceed to upgrade the 'ECM' with Event 854 software in **Manual Mode** only, **after** ITM part replacement is completed by referring to the ROM ID tables on pages 3-5.
5. Verify normal vehicle operation.

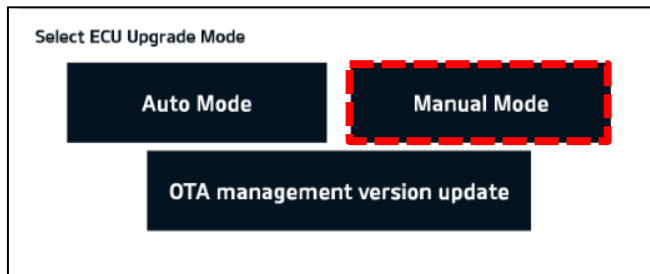
The required software must be installed by selecting the **'Manual Mode'** ECU Upgrade option.

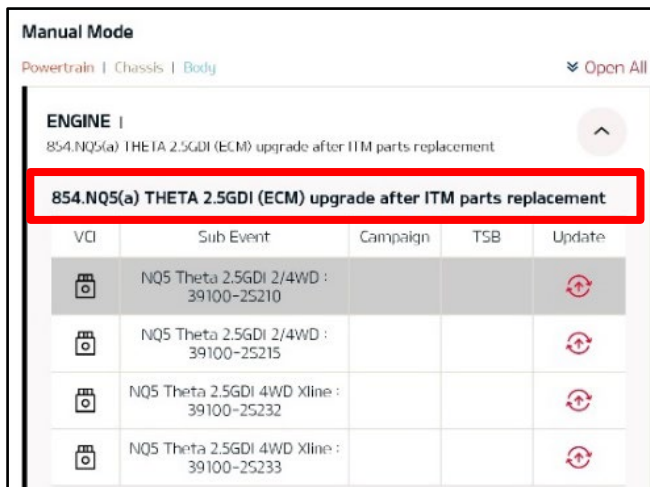
Select the applicable **'ECM'** system module and the Event Group.

- **854.NQ5(a) THETA 2.5GDI (ECM) Upgrade After ITM Parts Replacement**

Verify the affected vehicle Calibration Identification of the applicable ECU ROM ID and reference the Information Table on page 4 as necessary.
