TECHNICAL SERVICE BULLETIN

Unable To Open The Tailgate From The Release Handle

25-2430

Ford 2022-2025 Maverick	Built On Or Before 12-Jul-2025
-----------------------------------	--------------------------------

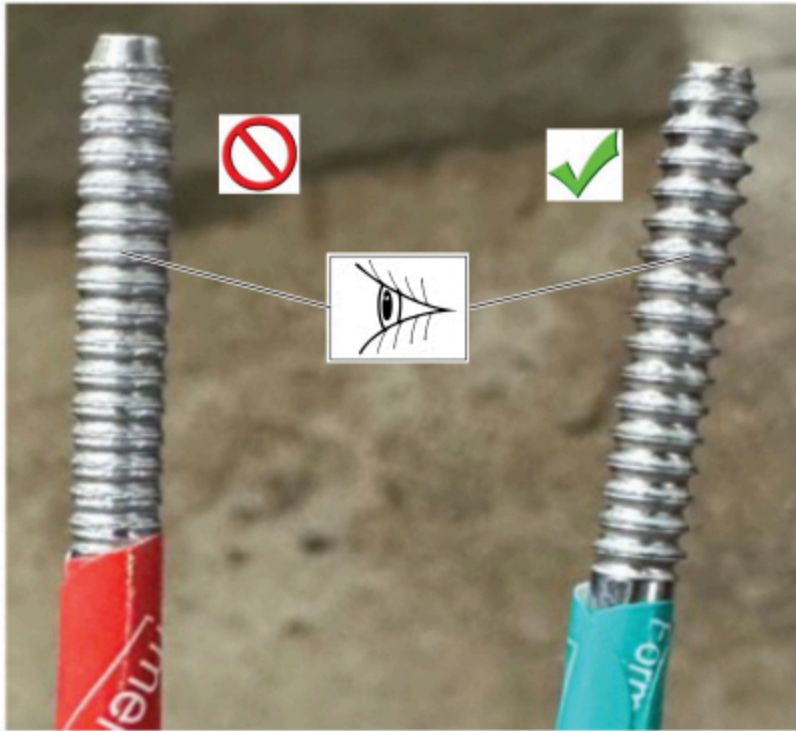
Figure 3

Issue: Some of the vehicles listed in the Model statement above may exhibit a condition where the tailgate is unable to open from the release handle. This may be due to damaged threads in one or both tailgate latch actuating rods.

2. Inspect both tailgate latch actuating rods for damaged threads as shown in Figure 3. Do the tailgate latch actuating rods exhibit damaged threads?

- (1). Yes - remove and discard the affected tailgate latch actuating rod(s). Refer to the WSM, Section 501-14 Handles, Locks, Latches and Entry Systems > Removal and Installation > Tailgate Latch. Proceed to Step 3.
 - (2). No - this article does not apply, perform normal diagnostics outside of this article. Refer to the WSM, Section 501-14 > Handles, Locks, Latches and Entry Systems > Diagnosis and Testing > Pinpoint test AB.
3. Install new tailgate latch actuating rod(s). Refer to the WSM, Section 501-14 Handles, Locks, Latches and Entry Systems > Removal and Installation > Tailgate Latch.
 4. To assemble the vehicle, reverse the removal procedure.
