MAS004768 RU 25-28

Rapid Update 788 Grecale – USB Port Trim Check

DATE: OCTOBER 10, 2025

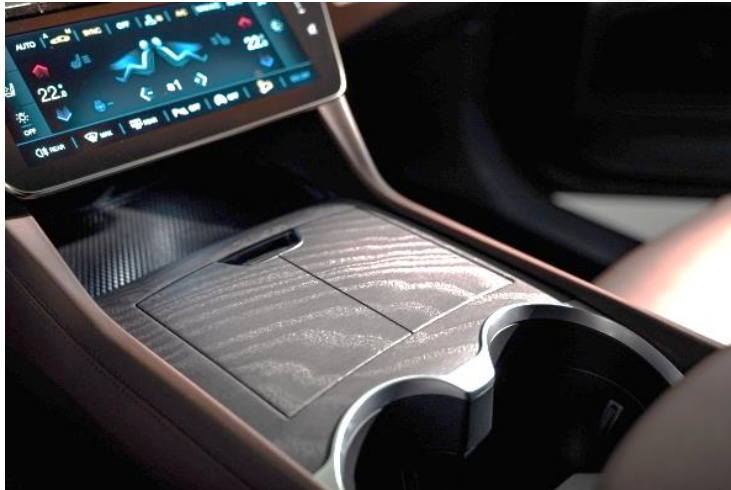
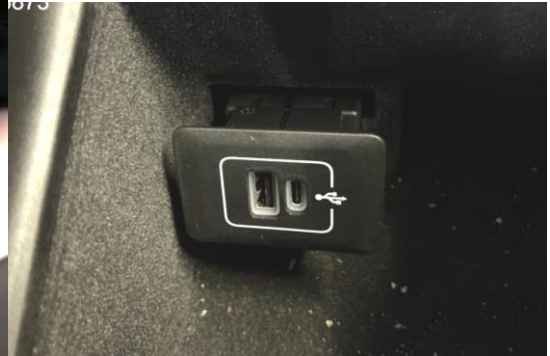
1. Always check ModisCS+ to see if the vehicle is involved in this action and if it has not been previously performed.
2. Before starting, make sure to apply adequate protection to the interior on the vehicle to avoid damage.
3. Locate the USB port in the center console storage compartment.

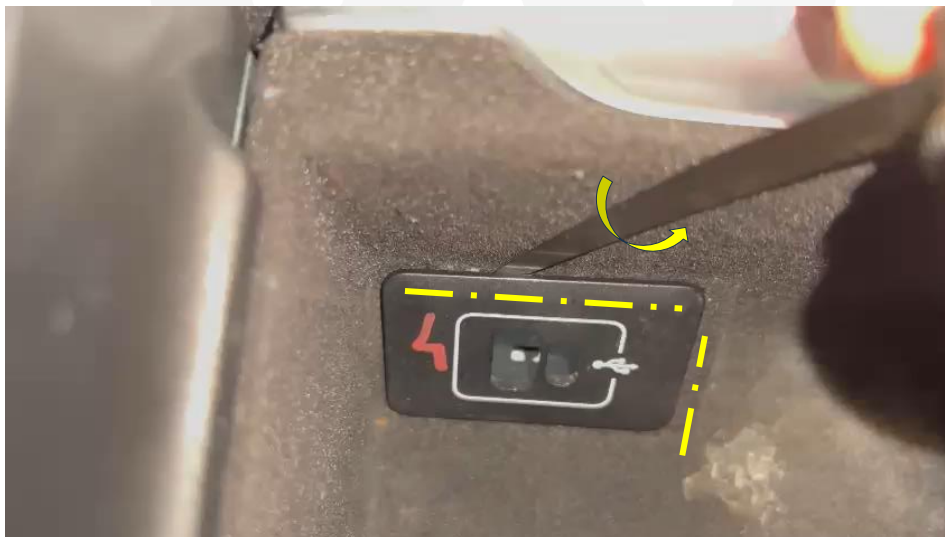
4. Manually move the USB port by hand to check for a secure fitment. Try and move it in all directions to see if it feels loose or lifts.
5. Use a 3mm thick plastic trim tool or feeler gauge:
Gently try to insert it between the trim and the storage compartment wall (top and right sides).
- Use a light rotary motion—do not force the tool.
⚠ Be careful not to scratch the trim or interior.

6. Evaluation:
 - If the gauge doesn't fit and the trim is secure → Vehicle is OK.
 - If the trim lifts or detaches → Replace the trim.
7. Reassemble all parts in reverse order after replacement.
8. Procedure complete.
