Rapid Update 798

Grecale - Rear Diff Cable Clip Check

DATE: OCTOBER 1, 2025

VEHICLES INVOLVED: Grecale (M182) MY24 MY25

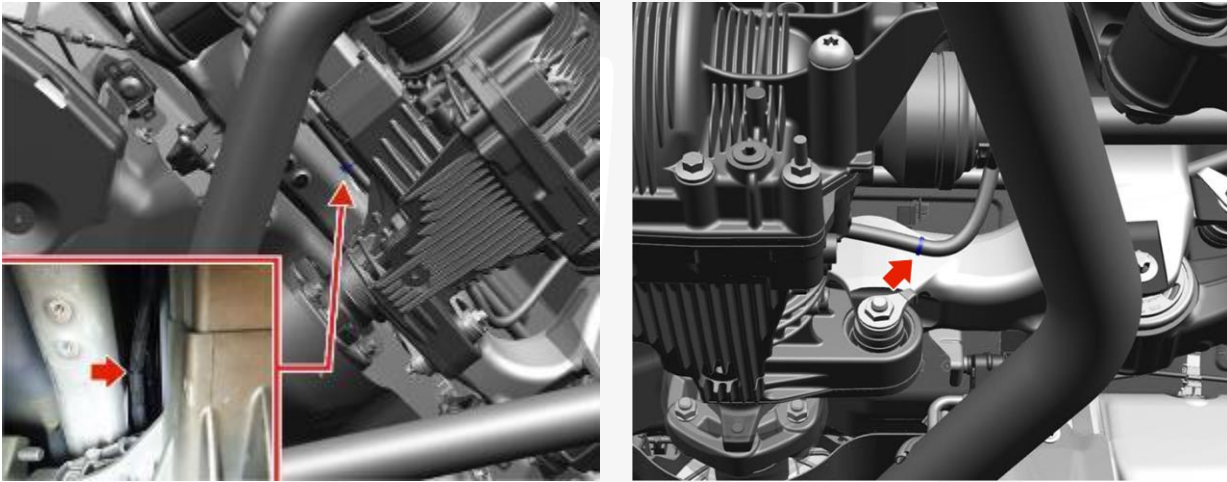
- Locate the clip securing the rear differential wiring harness to the frame.
- Gently tug the cable to ensure the clip is secure and not at risk of opening.

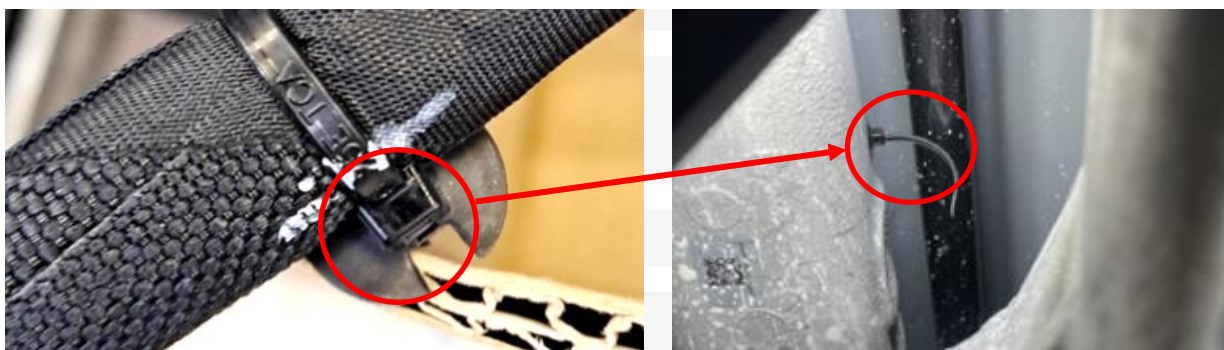
Figure 1: If the excess strip is cut too close to the cable tie head, the clamp may open as shown in the photo on the right. Replace as needed

- Inspect the wiring harness covering for signs of abrasion or wear.
 - If damage is found, remove the protective sheath and inspect individual wires.
 - If wires are damaged, repair them per Workshop Manual **0.30.005 – Cable and Connector Repair**.
 - Rewrap the area with anti-abrasive cloth tape.
- **Note :** Although no damage is expected on the wiring branch, **as a precaution, perform** the check and open a report at the BOL as "**Information to the factory**" to document the damage found.

- If the cable is undamaged, restore the clip using the correct part.
