**Technical Service Bulletin (TSB)**  
**Brake Warning Lamp On**

<b>REFERENCE:</b>	<b>TSB:</b> 08-275-25 REV. A <b>GROUP:</b> 08 - Electrical	<b>Date:</b>	October 11, 2025	<b>REVISION:</b>	08-275-25
<b>VEHICLES AFFECTED:</b>	<b>2025 - 2026 (B1) Jeep Renegade</b> <b>2025 - 2026 (H1) Jeep Commander</b> <b>2025 - 2026 (M1) Jeep Compass</b> <b>2025 - 2026 (N4) RAM Rampage</b> This bulletin applies to vehicles built on or after <b>**July 01, 2025 (MDH 0701XX)</b> and on or before <b>September 26, 2025 (MDH 0926XX)**</b> .			<b>MARKET APPLICABILITY:</b> <input type="checkbox"/> NA <input type="checkbox"/> MEA <input checked="" type="checkbox"/> SA <input type="checkbox"/> IAP <input type="checkbox"/> EE <input type="checkbox"/> CH <b>NOTE:</b> This bulletin applies to the South America market.	
<b>CUSTOMER SYMPTOM:</b>	Customers may experience a Malfunction Indicator Lamp (MIL) illumination and the vehicle may exhibit/set the following Diagnostic Trouble Code (DTC): <ul style="list-style-type: none"> <li>• C1215-86 - Brake Light Switch - Signal Invalid.</li> </ul> Customers may comment on one or more of the following: <ul style="list-style-type: none"> <li>• "ABS" warning displays on th

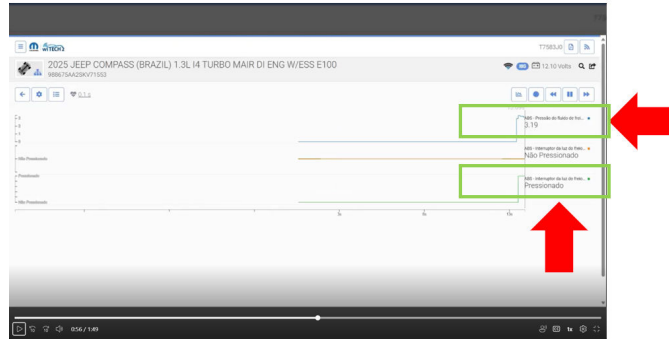
**Fig. 6**

8. Monitor through the graphs the behavior by slowly stepping on the brake pedal, when activating the first stage of the switch the pressure should be up to 4 Bar (H1/ M1 / N4) and 6 Bar (B1) [Fig. 6](#).

9. Is the Bar pressure greater than 4 Bar (H1/ M1 / N4) and 6 Bar (B1) [Fig. 6](#)?
  - a. YES>>> Proceed To Step 10.
  - b. NO>>> This bulletin has been completed. Use Inspection LOP (08-80-84-90) to close the active RSU.
10. Disconnect the negative battery terminal.

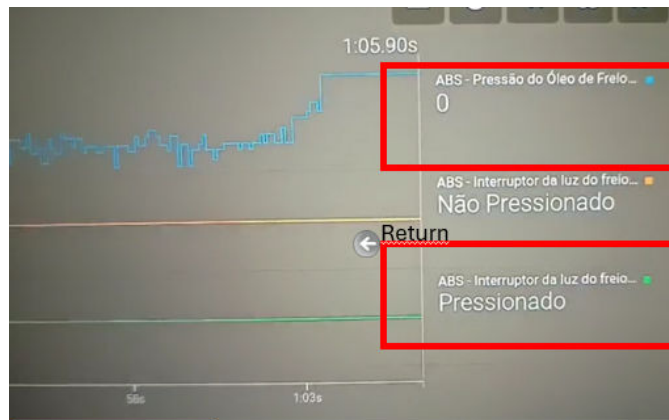
**Fig. 7**

12. Position the switch on its seat on the pedal and turn it clockwise, until it is completely fixed (you will notice the click of the lock).
13. Connect the negative battery terminal.
14. Clear DTCs.
15. Start the engine, place the transmission in Park "P" position and deactivate the parking brake.
16. Check the residual brake pressure again [Fig. 7](#) by monitoring through the graphs the behavior by slowly stepping on the brake pedal, when activating the first stage of the switch the pressure should be less than or equal to 4 Bar (H1/ M1 / N4) and 6 Bar (B1) or less than or equal to 6 Bar (Renegade).
