REFERENCE:	TSB: 11-002-25 REV. A GROUP: 11 - Exhaust System	Date:	October 8, 2025	REVISION:	11-002-25
VEHICLES AFFECTED:	2025 (WL) Jeep Grand Cherokee This bulletin applies to vehicles built on or after **June 25, 2025 (MDH 0625XX)** and on or before July 25, 2025 (MDH 0725XX) equipped with one of the following engines: <ul style="list-style-type: none"> • 3.6L V6 24V VVT Engine (Sales Code ERB). • 3.6L V6 24V VVT Engine Upg I w/ESS (Sales Code ERC). • 3.6L V6 24V VVT Engine (Sales Code ERF). • 3.6L V6 24V VVT eTorque Engine Upg I (Sales Code ERG). 			MARKET APPLICABILITY: <input checked="" type="checkbox"/> NA <input type="checkbox"/> MEA <input type="checkbox"/> SA <input type="checkbox"/> IAP <input type="checkbox"/> EE <input type="checkbox"/> CH NOTE: This bulletin applies to the North America market.	
CUSTOMER SYMPTOM:	Customers may experience the following: <ul style="list-style-type: none"> • Exhaust rattle going over bumps and on rough roads.

CAUSE:	Loose/missing muffler hanger fastener(s)

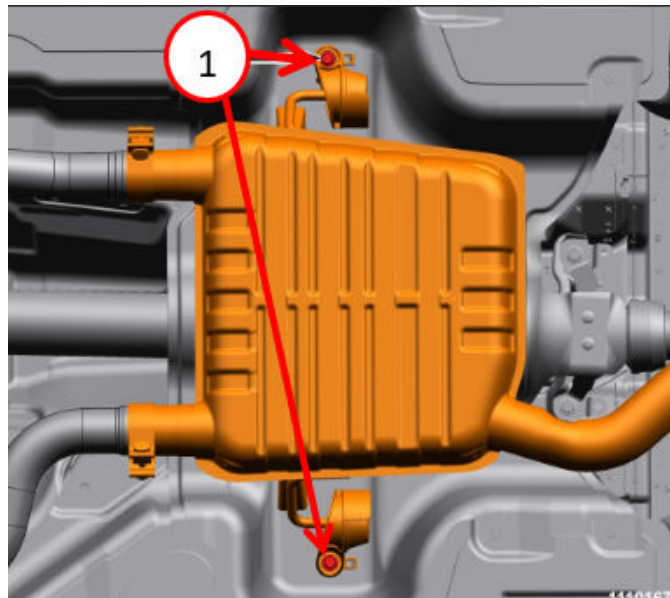
Fig. 1
Muffler Hanger Fasteners

1 - Muffler Hanger Fasteners

3. Are the muffler hanger fastener(s) loose/missing?
 - YES>>> Proceed to [Step 4](#).
 - NO>>> This bulletin has been completed, lower the vehicle. Use Inspect LOP (11-40-10-99) to close this active RSU. Perform further diagnosis.
4. Tighten the fasteners to 25 ft. lbs. (33 N·m). If fasteners are missing, install new fasteners and tighten to 25 ft. lbs. (33 N·m).
5. Lower the vehicle.
