Technical Service Bulletin (TSB)
Global Telematics Box Module (TBM) Firmware Over The Air (FOTA) Update From R5N to R5T Software Level

REFERENCE:	TSB: 08-339-25 GROUP: 08 - Electrical	Date:	October 9, 2025	REVISION:	—
VEHICLES AFFECTED:	2025 - 2026 (DT) RAM 1500 Pickup This bulletin applies to vehicles equipped with Global Telematics Box Module (TBM) (Sales Code RDG).			MARKET APPLICABILITY: <input checked="" type="checkbox"/> NA <input type="checkbox"/> MEA <input type="checkbox"/> SA <input type="checkbox"/> IAP <input type="checkbox"/> EE <input type="checkbox"/> CH NOTE: This bulletin applies to the North America market.	
CUSTOMER SYMPTOM:	The customer may comment on the following: <ul style="list-style-type: none"> Radio screen displays "Uconnect Box Error" with the message "Uconnect Box requires service. Please visit an authorized dealer" Fig. 1. Rear View Camera (RVC) functions normally. 				
CAUSE:	Issue With Antenna Startup Time

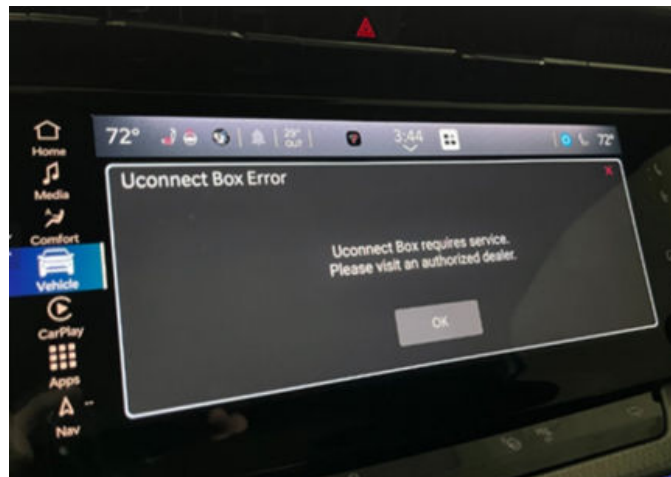
Fig. 1
Uconnect Error Message

This bulletin provides information regarding the latest Firmware Over The Air (FOTA) update and provides the service technician an overview of the steps a customer will need to take to complete the update. The TBM software will be updated from R5N to R5T software level.

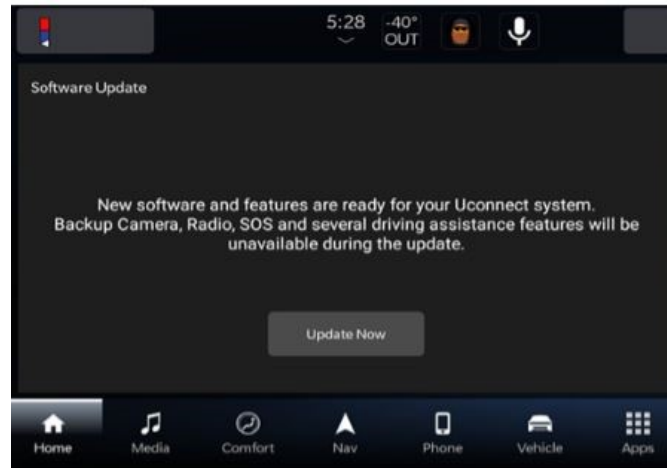
**Fig. 2**

Software Acceptance Screen

1. The vehicle needs to be in 'Park'. The ignition needs to be in the off position.
2. If the customer selects “Update Now” [Fig. 3](#) they can shut off the vehicle and leave. The update will be completed automatically.

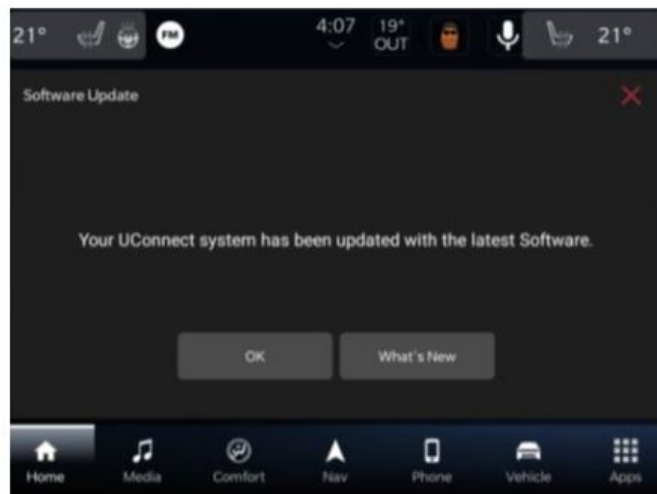
**Fig. 3**

Software Update Confirmation Screen

3. Upon completion of update, the radio will display a confirmation message [Fig. 3](#).
