Service Bulletin

Bulletin No.: 22-NA-080

Subject: Diagnostic Tips for Engine Related Shudder Concerns

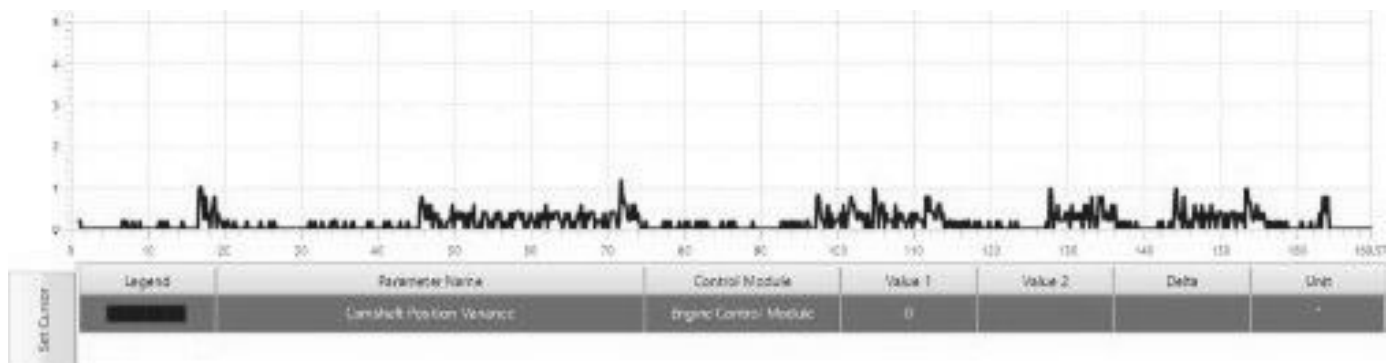
Normal operation (variance under 4 degrees)

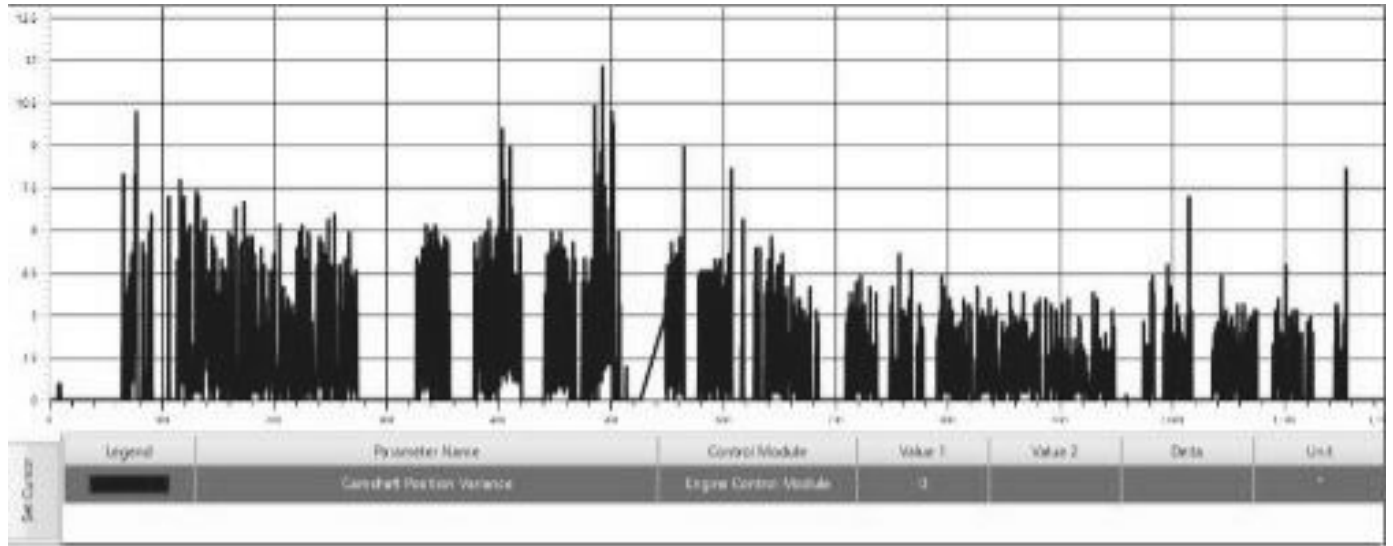
6029096

| Cause | This condition may be caused by the camshaft actuator magnet sticking. |

Suspect fault in camshaft actuator system (variance over 4 degrees)

| Correction | If the concern has been determined to be engine related and not being caused by the transmission the following diagnosis may be helpful: - While duplicating the Shudder or Surge concern monitor the data parameter "Camshaft Position Variance" in GDS2. Although target variance is 0 degrees, it is not uncommon to observe variance of up to 3-4 degrees on a properly functioning system. - Any variance exceeding 3-4 degrees could potentially cause a noticeable Shudder or Surge concern. If after diagnosis you confirm that the concern has been isolated to the camshaft actuator system, it is recommended to replace the camshaft actuator magnet and re-evaluate. Refer to <i>Camshaft Position Actuator Magnet Replacement in SI</i> . If the Shudder/Surge is still present after camshaft actuator magnet replacement and camshaft actuator variance is over 4 degrees, refer to GM Service Information for further diagnosis. |
