Service Bulletin

Bulletin No.: 23-NA-119

Subject: Shift to Park is Displayed on the Driver Information Center (DIC) When Vehicle is in Park, No Start - DTC B000A Set

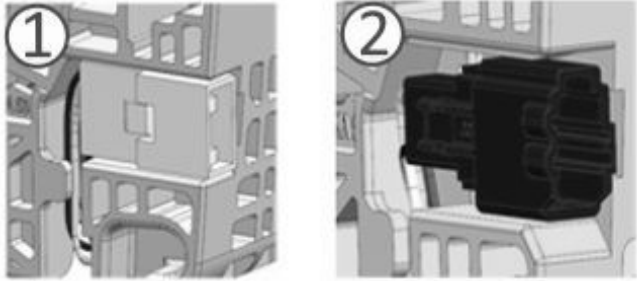
Important: Inspect the electrical connector for validation before ordering the part.

6736304				
X	CONTROL ASM-A/ TRNS (W/O BASE)	Malibu 6-way Connector (1)	13545095	1
X		Malibu 8-way Connector (2)	13545102	1
X		Encore GX, Trailblazer 6-way Connector	13545091	1
X		Encore GX, Trailblazer 8-way Connector	60006582	1
