GENERAL MOTORS  
DCS7346  
URGENT - DISTRIBUTE IMMEDIATELY

Subject: N232401570 - Service Update  
Cell Monitoring Unit Offline

# Service Update

## N232401570 Cell Monitoring Unit Offline

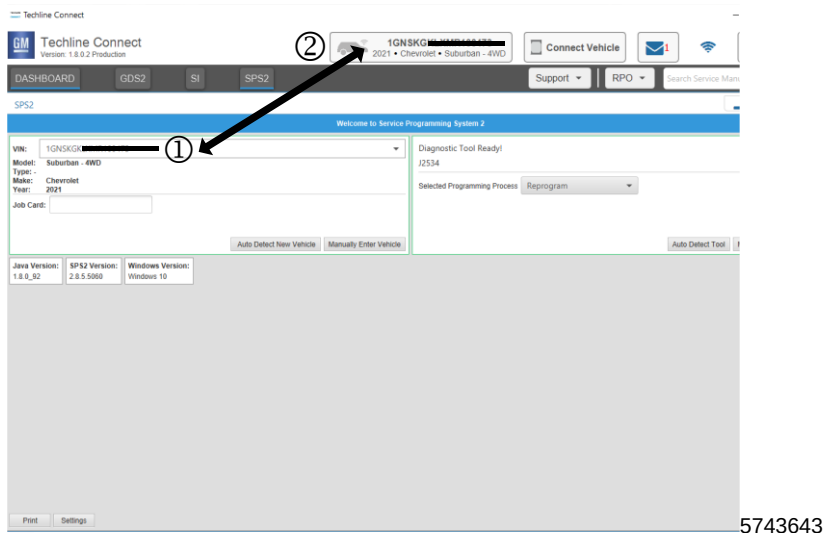
**Caution:** Be sure the VIN selected in the drop down menu (1) is the same as the vehicle connected (2) before beginning programming.

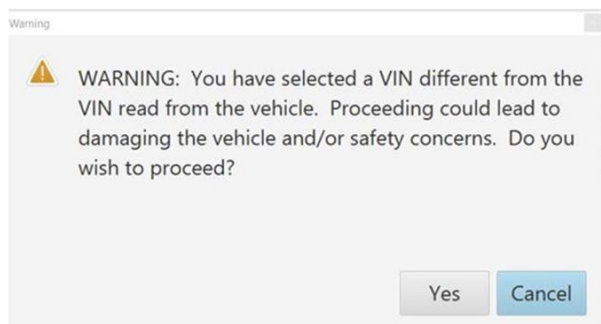
**Important:** If the vehicle VIN DOES NOT match, the message below will be shown.
