SIB 54 05 25

POPPING SOUND IS HEARD COMING FROM THE ROOF/B-PILLAR

2025-10-08

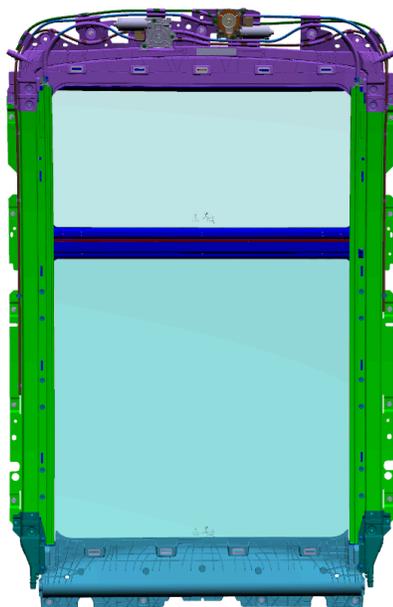
A “popping” sound is heard coming from the Roof/B-pillar area when driving over small driveway curbs.

Apply blue Loctite to the sunroof cassette bolts.

- The exact locations of the affected bolts are indicated in the repair instructions referenced below
