## SIM 51 04 25

### FRONT DOOR POWER WINDOW(S) ARE INOPERATIVE

E-Series	Model Description	Production Date
U25	MINI Countryman	October 31, 2023 – September 29, 2025

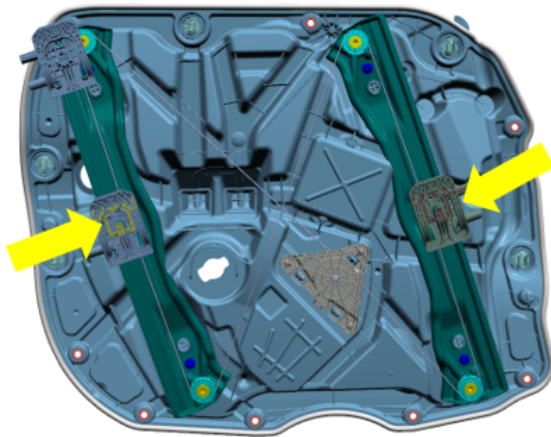
Front door power windows (left and/or right side) do not function.

If the window(s) do operate, a grinding sound can be heard while opening and/or closing.

During the vehicle assembly, too much force was applied when the window glass was installed into the lifter plates (**yellow arrows are pointing to the lifter plates**).

Replace the door carrier of the affected door.
