**Subject: Loss of Steering Assist and/or Loss of Brake Assist Malfunction Indicator Lamp (MIL) Illuminated - DTCs P25A2, U0422, C1595, U0420, C116C, B3205, B127B, B1325, C1597 and/or C1599 Set**

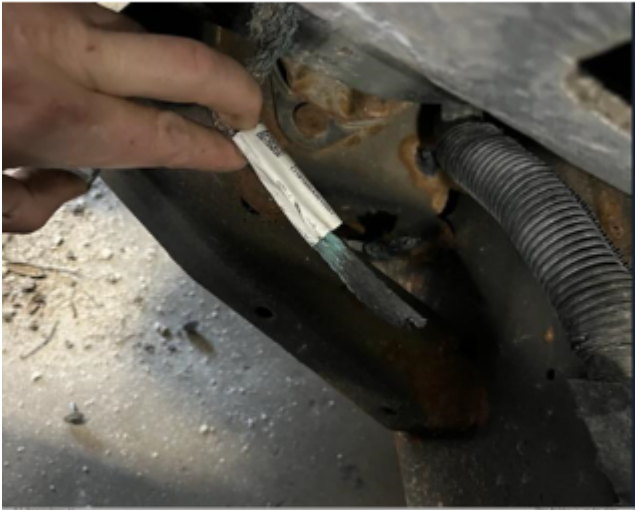
6483337

This condition may be caused by High resistance in the G132 and G133 grounds, located behind the RH wheelhouse liner.
