# Service Bulletin

Bulletin No.: 25-NA-170

**Subject: Loss of Air Conditioning, Weak Cooling, and/or Warm Air Coming from Vents**

| Brand: | Model: | Model Year: | | Breakpoint: | | Engine: | Transmission: |
|---|---|---|---|---|---|---|---|
| Chevrolet | Silverado 1500 | 2024 | 2025 | — | — | All | — |

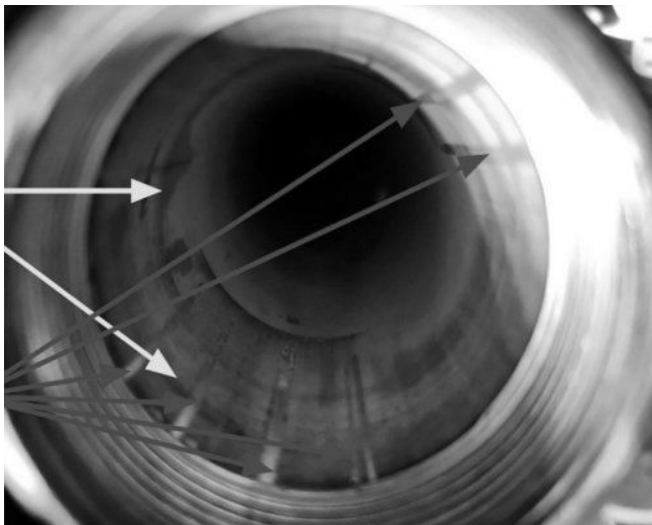
| Cause | <p>The condition may be due to scoring on the inside of the desiccant chamber, as shown in the picture above (red arrows), causing a slow leak of refrigerant at the receiver/dryer desiccant cap.</p> |

| Correction | Technicians will need to inspect the desiccant cap extensively using a refrigerant sniffer or use a soapy solution to observe for leak prior to part replacement.<br><b>Note:</b> The bubble test will only work on vehicles built in this window. (The soap/bubble method may create false positives on other vehicles). |
