QUALITY ACTION

CAMPAIGN BULLETIN

Shorting Terminal

P5A27 – 2026 LEAF DEFROST SHORTING TERMINAL

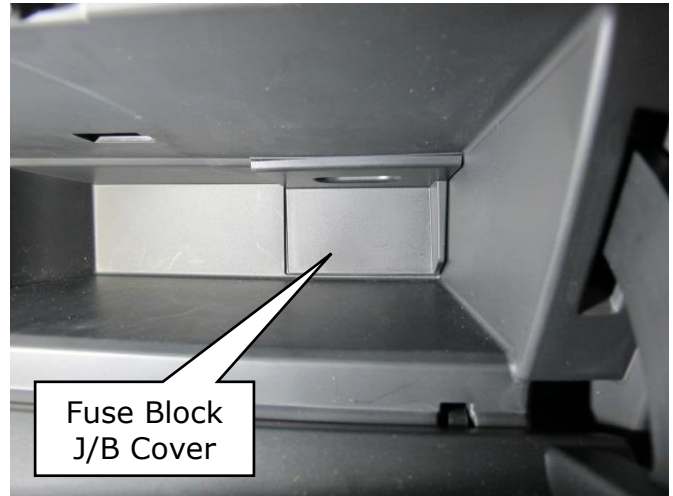
Figure 3

3. Locate the fuse block J/B cover inside the glovebox.
- The fuse block J/B cover will be located on the back right side of the glovebox

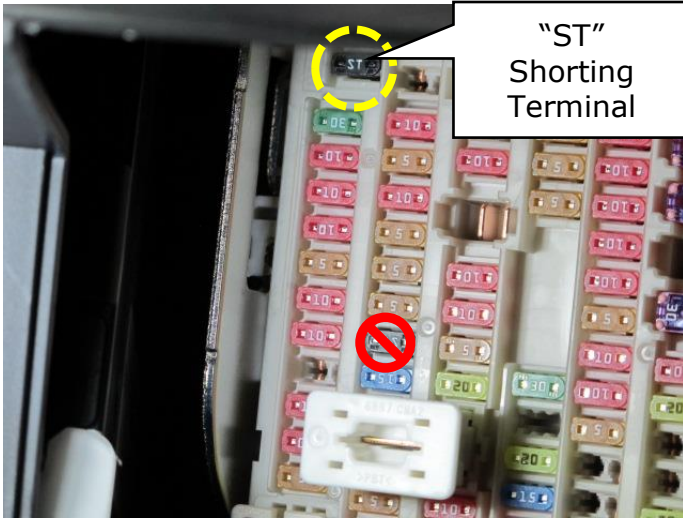
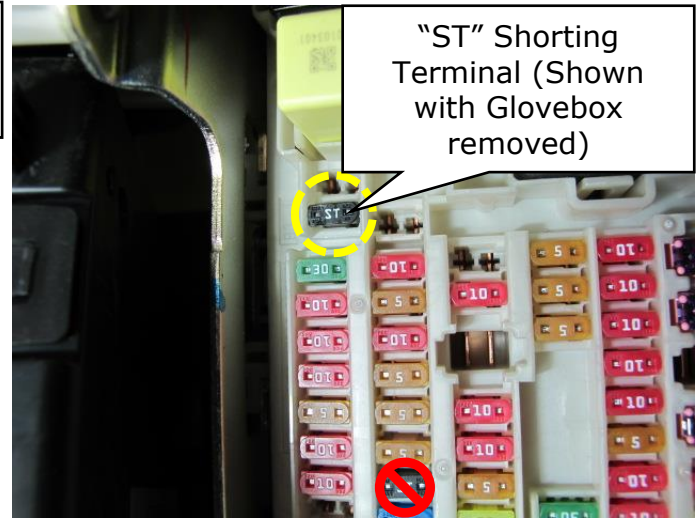
Figure 5

5. Locate the fuse block J/B black "ST" shorting terminal in the upper left corner.
- Refer to Figures 5 and 6

There are (2) black "ST" shorting terminals in the fuse block J/B. This procedure only applies to the one in the upper left corner of the fuse block J/B.
