Technical Service Bulletin

Topic	Dynamic ride system warning visible - DTC P0B2500 logged within address 0021 (Battery Energy Control Module 2)
Market area	Bentley: worldwide (2WBE),China 796 VW Import Comp. Ltd (Vico), Beijing (6796)
Brand	Bentley
Transaction No.	2068946/10
Level	EH
Status	Released for publishing
Release date	Oct 8, 2025

Bentayga Series/New Continental GT/C and New Flying Spur

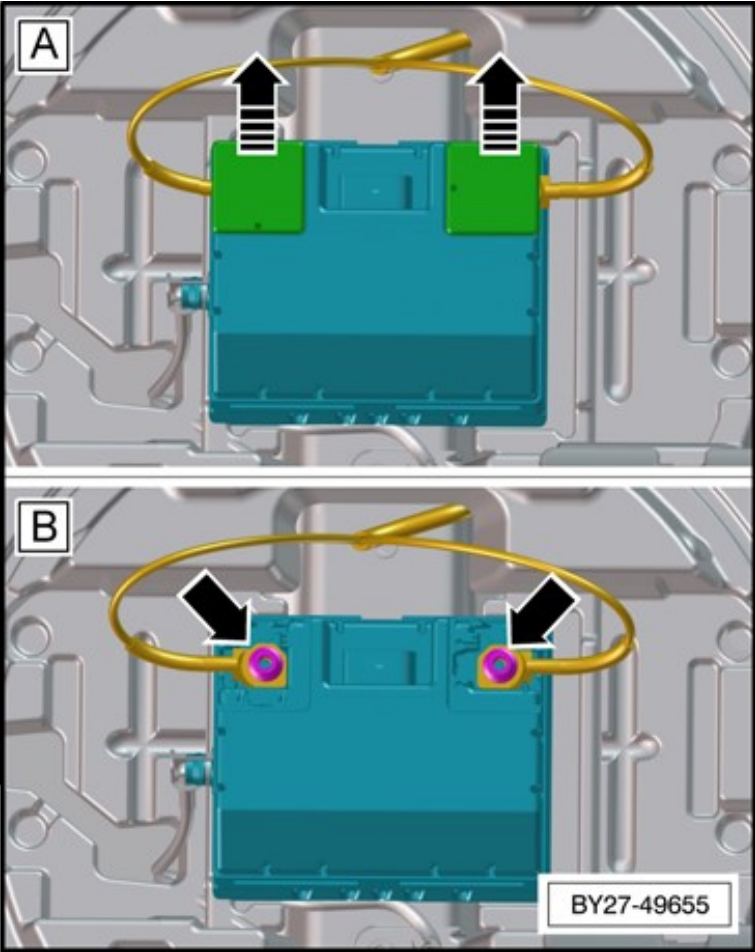
Figure 1

Possible internal fault with the super capacitor

- 1) Referring to Rep.Gr 27 - Deactivate the 48 volt system - Refer to 48 volt system - To activate and deactivate
- 2) Referring to Rep.Gr 27 - Check the security of the super capacitor positive and negative terminals (Figure 1) as follows:
 - Remove the caps (A) from the terminals
 - Check the security of the positive and negative terminals (B) are as described within Rep.Gr 27

- In the event that one or both terminals were not tightened to the correct torque as Rep.Gr 27, the operative must tighten the terminal(s) to the correct torque as detailed within Rep.Gr 27 - Super capacitor

In the event one or both terminals required tightening to the correct torque (found to be not initially secure) the operative must feedback the findings via DISS
