# Service Bulletin

Bulletin No.: PIC6601B

**Subject: Diagnostic Tip: Rattle Tick Creak Noise in Dash**

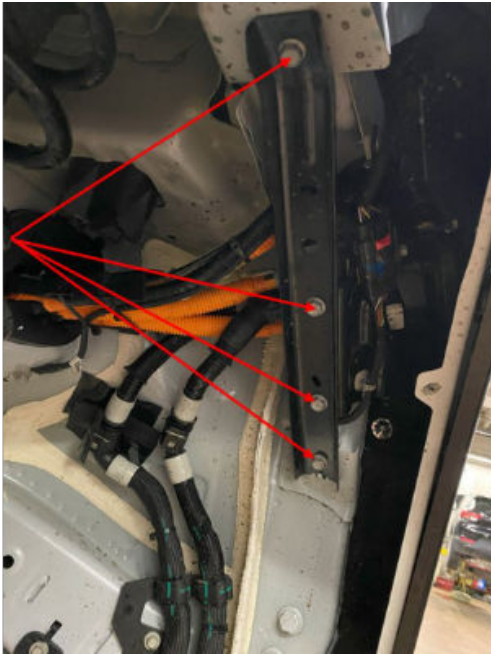
6886873

<b>Involved Region or Country</b>	North America
<b>Condition</b>	Customers may comment on a creak, rattle or, tick noise from the LH side of the dash over small bumps and during parking lot type maneuvers.
<b>Cause</b>	Possible loose front compartment upper side rail brace bolts in the LF wheel well.

Inspect the Body Hinge Pillar Brace bolts for looseness.

If loose, torque fasteners to 22 Nm (16 lb ft), then re-install wheelhouse liner.
