Service Bulletin

Bulletin No.: PIP6088

Subject: Check Engine Light / MIL After Installation Of A Remanufactured Valve Body

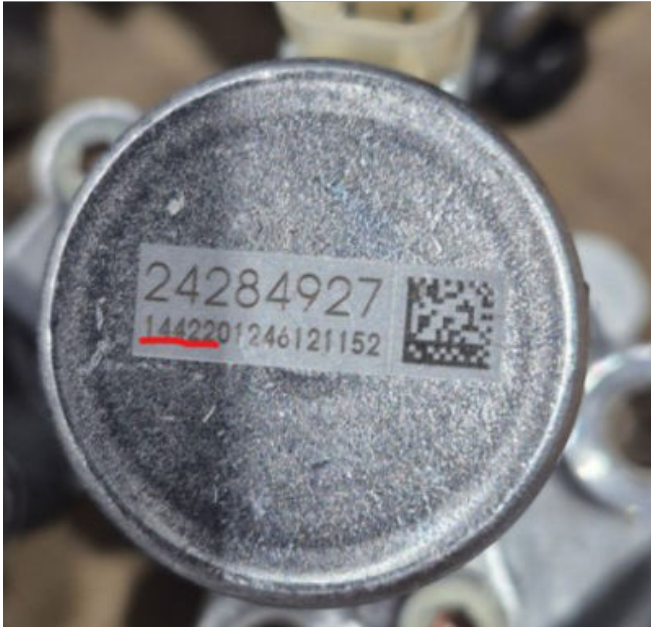
Solenoid Julian Date Location.

7004529

Note: The first 3 digits are the Julian Date and the 2 digits following that are the year

Suspect solenoids are built with a Julian Date of 06025 through 20225.

If the solenoid is found within this breakpoint ONLY the solenoid should be replaced.

If the solenoid falls outside of this range normal SI diagnostics should be followed.
