Service Bulletin

Bulletin No.: PIC6622

Subject: Folding Top Inoperative - Erratic Operation

Brand:	Model:	Model Year:		VIN:		Engine:	Transmission:
		from	to	from	to		
Chevrolet	Corvette	2024	2026	All	All	All	All

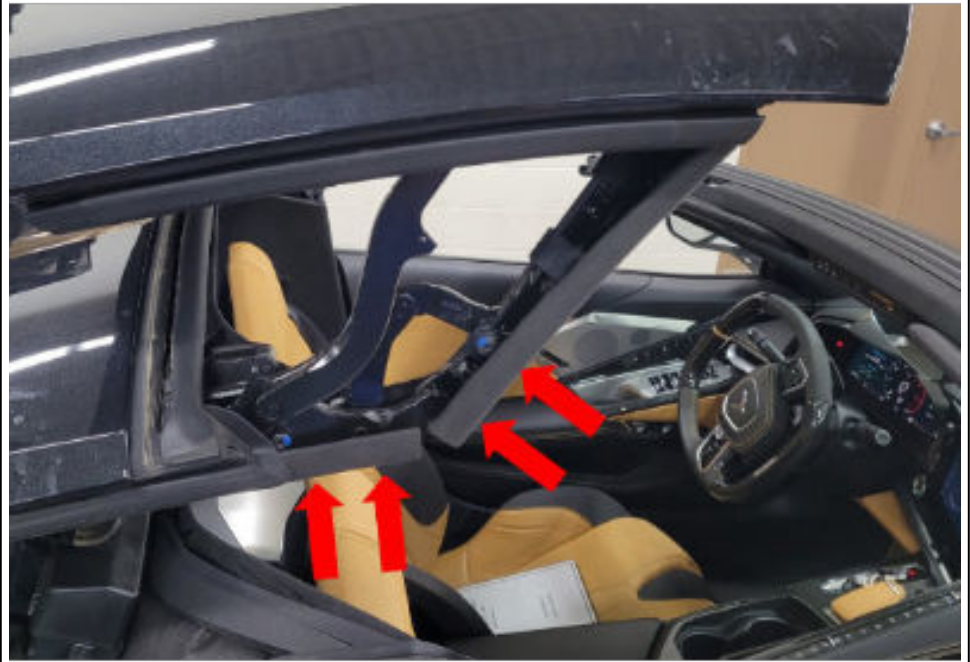
7005159

Involved Region or Country	North America
Additional Options (RPO)	CM9 - Power Retractable Hard Top W/ Remote Activation (down only).
Condition	Some customer's may comment about an inoperative folding top on their vehicle. Others may comment about intermittent, or erratic operation from the folding top. This concern may be accompanied by any folding top or CAN bus related DTCs. The following DTCs may be set, but not limited to: B19EA, B1A51, B19E0, B19E1, B19E7, B19E8, U1105, U1106, U1107, U1108 and/or a U0079. The Folding Top Module power supply fuses F23RA, F24RA, F25RA, or the F26RA may be open as well.
Cause	This concern may be caused by a broken wiring harness on either the RH or the LH side rail of the folding top system. The general location of this concern may be found in between the roof panels, when the linkage folds in half as seen in the photos below. Zoomed out view showing the hinge location of the possible broken wiring harness.

If any of these symptoms are experienced, dealership technicians are to closely inspect the wiring harness that runs fore/aft along the LH and the RH main folding top side rails. The wiring harness can become pinched in either side rail on the folding top.

If any wiring / harness damage is found, repair the circuit(s) as needed.

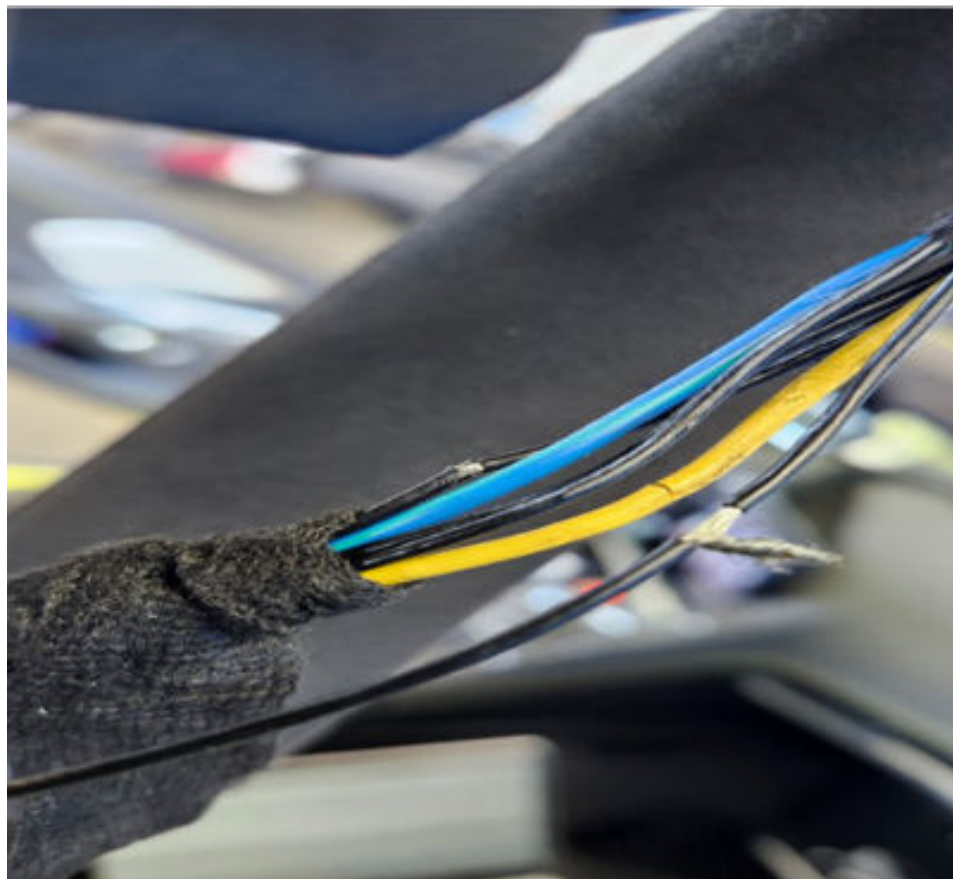
7005160

Zoomed in view of the same location showing actual wiring damage.

Note: Because of the armor tape and/or convoluted tubing that is used to cover the various locations of wiring harness on this folding top, dealership technicians may be required to remove the tubing and cut open the armor tape to physically inspect the condition of the wiring harness inside this protective layer. In many instances it is found that no damage whatsoever will be seen to the outer shield, but when peeled back, clear damage to the wiring circuits has been found.
