GROUP	MODEL
BOD	2021-2024MY Seltos (SP2)
NUMBER	DATE
326 (Rev 1, 10/20/2025)	July 2024

TECHNICAL SERVICE BULLETIN

HORN ASSEMBLY INSPECTION/REPLACEMENT

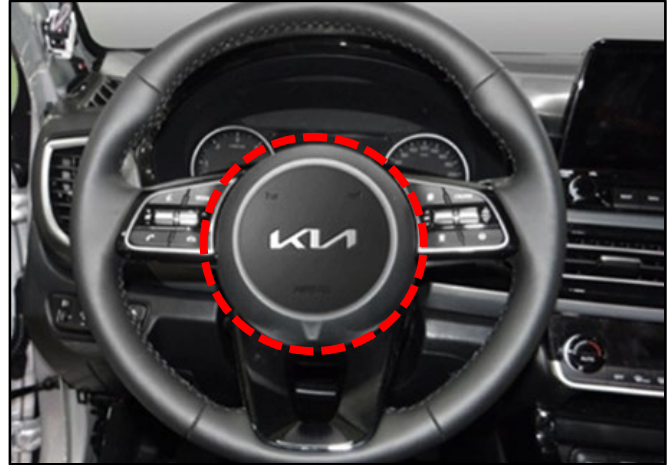
- Press the Horn Pad to confirm normal operation.
 - If the horn operates **normally**, this TSB does not apply. **Claim inspection only labor op 242044R1.**
 - If the horn is **inoperative** or the **tone is distorted**, proceed to the 'Replacement Procedure' below.

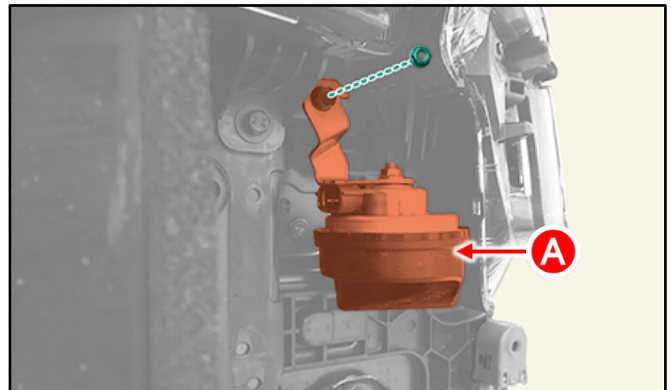
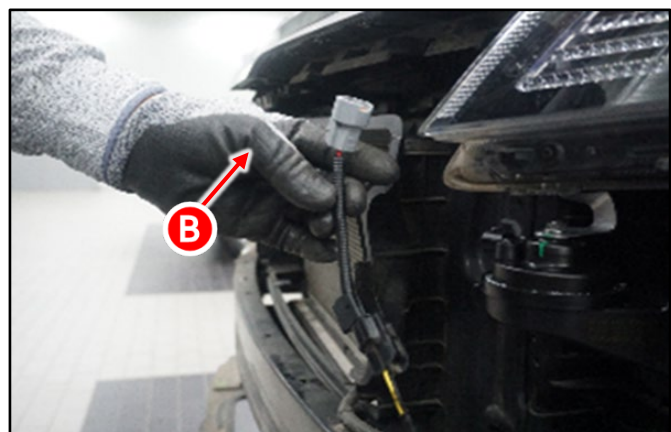
The replacement horn has reversed polarity compared to the original. Use the supplied extension harness to ensure proper connection.

- Replace the Horn (B) by referring to "Body Electrical System → Horn → Repair procedures" in the applicable Shop Manual on KGIS.
 - 21-23MY Seltos**
96611 Q5000QQK or **96641 Q5000QQK***
 - 2024MY Seltos**
96611 Q5100QQK or **96641 Q5200QQK**

21-23MY ONLY: If replacing the horn with **PN 96641 Q5000QQK*, it is required that the wiring harness extension (B) is also replaced simultaneously.**

- Reinstall all removed parts in the reverse order of removal.
- Confirm normal operation of the horn.
