Service Bulletin

Bulletin No.: 24-NA-235

Subject: Steering Column Rattle

Brand:	Model:	Model Year:		VIN:		Engine:	Transmission:
		from	to	from	to		
Chevrolet	Colorado	2023	2025	-	-	All	All
GMC	Canyon	2023	2025

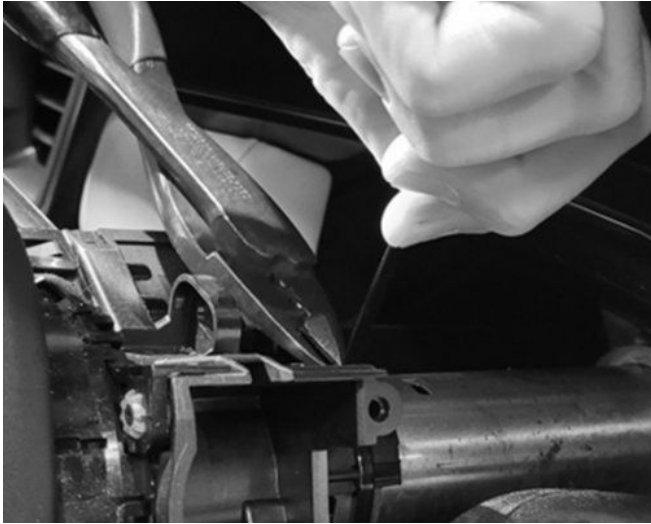
6754401

Involved Region or Country	North America, Israel, GM Korea Company, Middle East
Condition	Some customers may comment on a rattle or loose fit of the steering column turn signal switch. When they use the turn signal on to turn either direction, instead of self-cancelling off it will switch to the opposite direction for a few flashes. Note: If the customer comments on the turn signal over cancelling. If when using their turn signal in either direction, instead of self-cancelling it will switch to the opposite direction for a few flashes. Refer to TSB #24-NA-176.
Cause	The cause of the condition may be a loose fit of the turn signal / trim mounting bracket fitting loosely.
Correction	Secure around the midpoint of the turn signal mounting bracket by following the procedure outlined below.

4. Using an appropriate size tie strap, wrap the turn signal mounting bracket and tighten.
