# Service Bulletin

Bulletin No.: 25-NA-108

**Subject: Fluid Leak Under Vehicle**

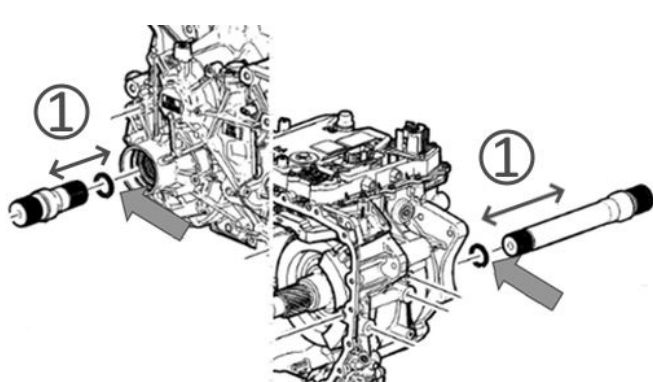
6908271

<b>Involved Region or Country</b>	North America
<b>Additional Options (RPOs)</b>	P8N: PRIMARY DRIVE UNIT - GEN 1, 77R, 1 MOTOR, INTERGRATED INVERTER, DRIVE UNIT
<b>Condition</b>	Some customers may comment on a fluid leak under the vehicle. Some technicians may find the fluid leak coming from the Drive Unit output shaft seal.
<b>Cause</b>	This condition may be caused by the output shaft losing retention and disengaging from the Drive Unit assembly.
<b>Correction</b>

<p><b>Note:</b> Up to 5mm of lateral movement is normal in the output shaft. For Drive Units that have more than 5mm lateral movement (1) or if they are leaking at the axle shaft, replace the Drive Unit.</p>

Refer to *Rear Electric Drive Transmission Module Replacement*.
