Technical Service Bulletin

GROUP	NUMBER
CAMPAIGN	25-01-077G
DATE	MODEL(S)
OCTOBER 2025	GV70 (JK1) GV80 (JX1) GV80 COUPE (JX1)

SUBJECT: LOOSE WINDSHIELD GLASS GARNISH SEAL
(SERVICE CAMPAIGN T84G)

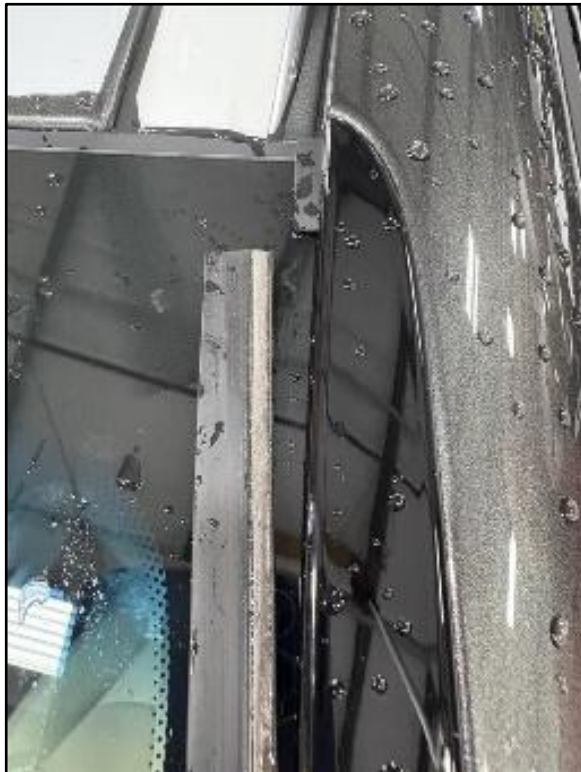
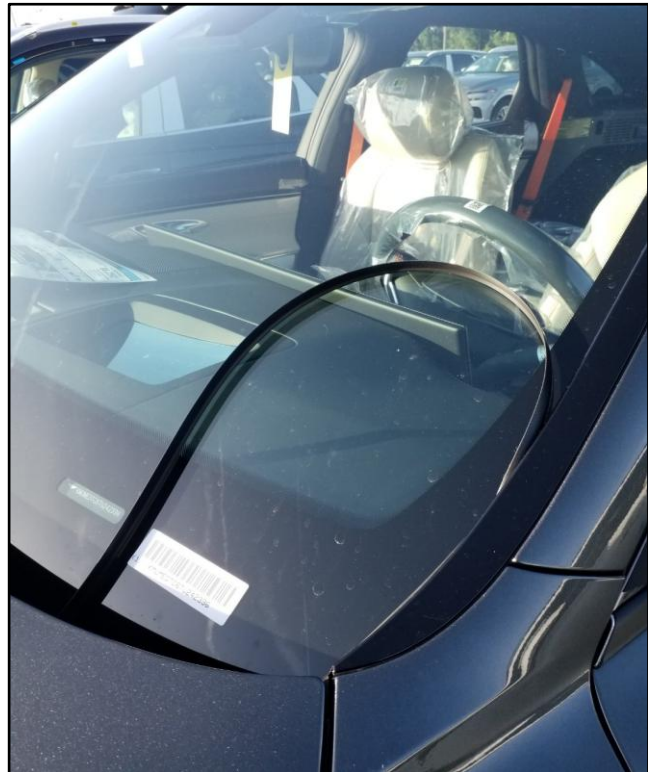
Description: Certain GV70 (JK1), GV80 (JX1), and GV80 Coupe (JX1) vehicles may exhibit a loose windshield glass garnish seal. This bulletin provides instructions to remove the old garnish and install new parts.

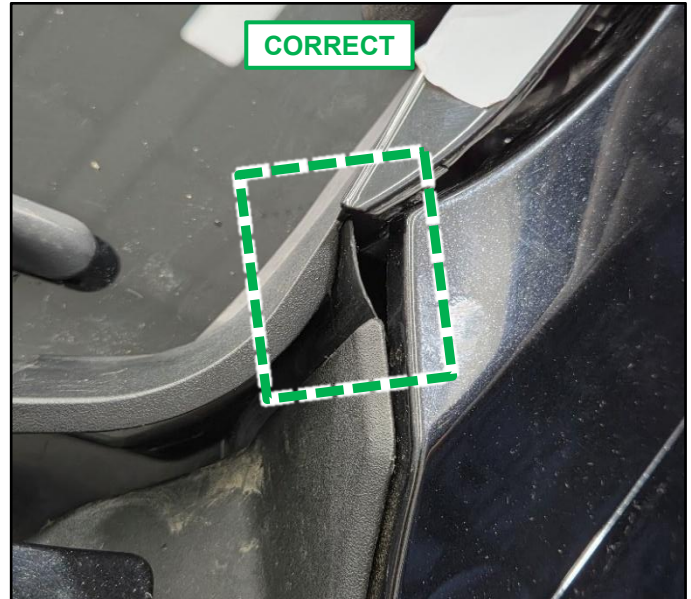
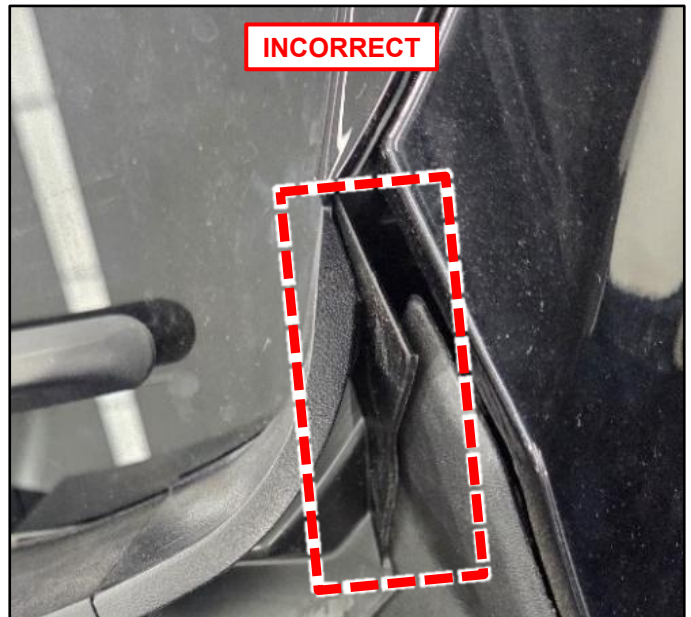
- **CORRECT**: Lower end of garnish is inserted between the cowl top cover and fender panel.
- **INCORRECT**: Lower end of garnish is **NOT** inserted between the cowl top cover and fender panel.

3. Install the new windshield glass garnish in the reverse order of removal.

Refer to the photos for examples of correct and incorrect installation:
